Ballyalbaney & Horseshoe Bridges

Stage 1 Quality Audit

Monaghan County Council

April 2023

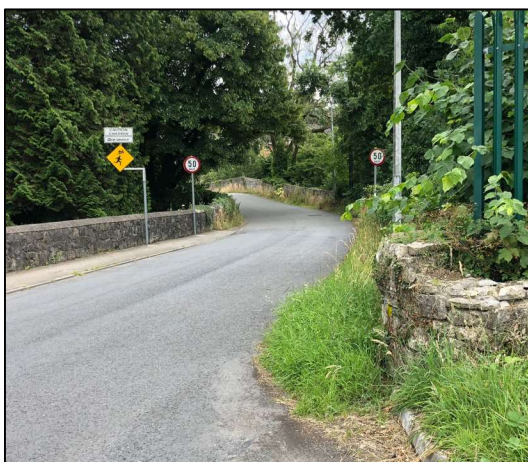
Figure 1-1 – Existing Ballyalbaney Bridge

The existing sites are both historical masonry stone arch bridges with no existing pedestrian facilities provided for. Both carriageways narrow on approach to the bridges from a single bidirectional carriageway to one lane. One footpath terminates on approach to each existing bridge.

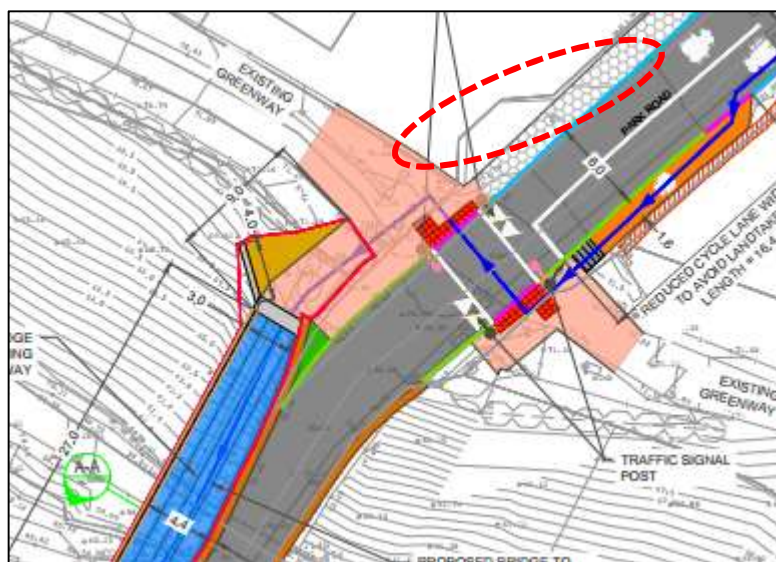
Figure 2-1 – Horseshoe Bridge Greenway

The existing greenway crosses Park Road at the Horseshoe bridge. Horseshoe bridge is also located just after the crest of a hill coming from Monaghan town centre. Lack of seating provision along the greenway and after a hill could prove challenging for less able users.

This may result in progression issues for less abled users.

The Designer should consider the need for provision of seating at the greenway entrance for less able users.

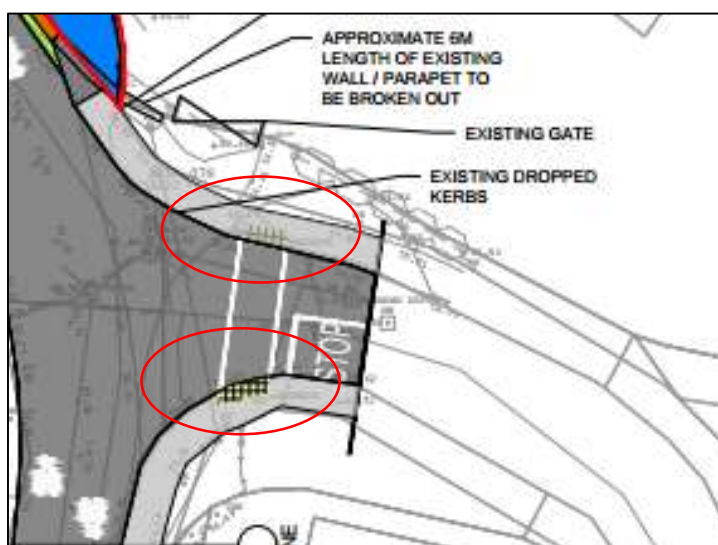
Figure 3-1 – In-Line Crossing Arrangement

The proposed crossing is considered an 'in-line' crossing at Coolshannagh Walk Junction at Ballyalbaney Bridge. The proposed tactile paving may not provide sufficient warning to visually impaired road users who may inadvertently step over the 800mm tactile zone and walk straight onto the carriageway where they could be struck by vehicles.

The Designer should extend the depth of the tactiles in accordance with best practice to 3 tactiles deep at all inline crossings.

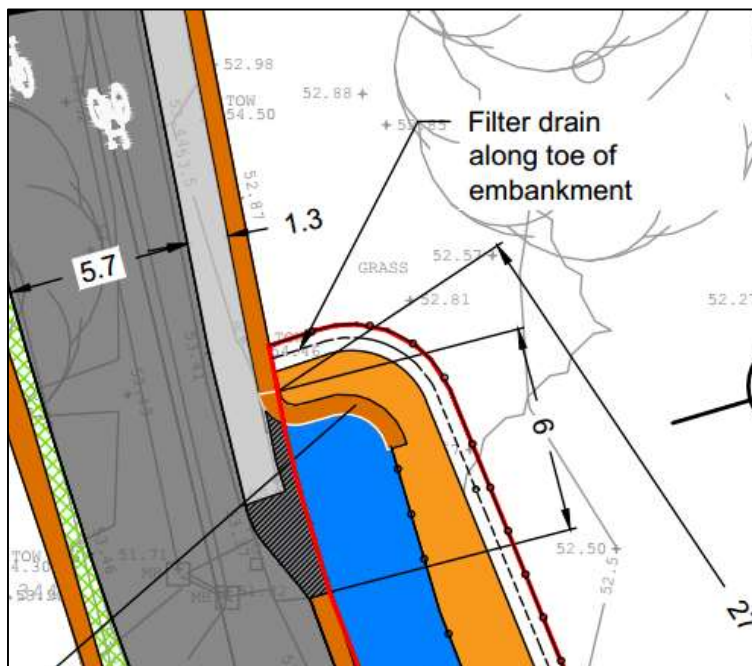
Figure 3-2 – Proposed Concrete Footpath

The designer has indicated the presence a proposed infill of concrete between the existing footpath and proposed bridge footway. The infill / modest additions of concrete may lead to a number of increase joints and potential trip hazards.

The Designer should extend the concrete footpath to eliminate number of joints within tie-in areas.

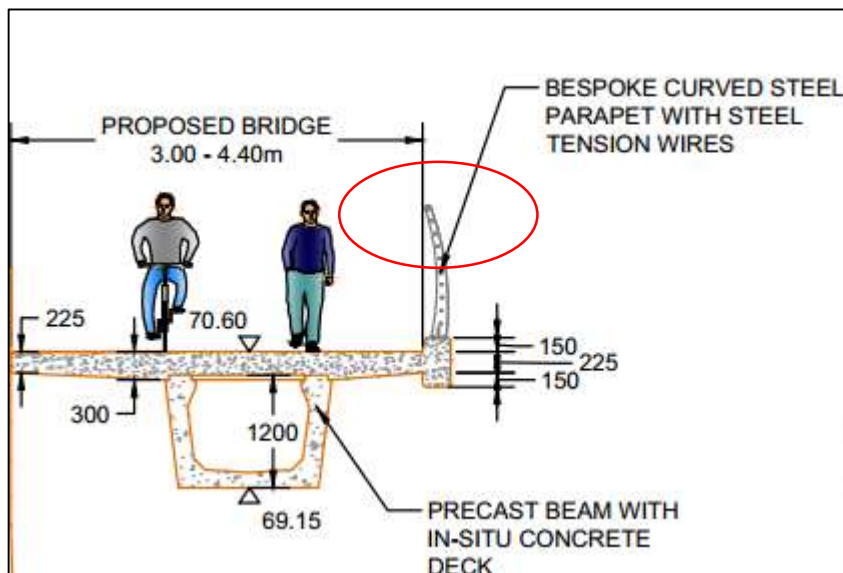
Figure 3-3 – Proposed Parapet

The design drawings show a parapet as shown below **Figure 3-3**. If the parapet end is not suitably transitioned/ terminated this may leave sections of the parapet where pedestrians may become snagged which could result in pedestrian injury.

The Designer should ensure the end of each parapet are designed to prevent any snagging on the end/ beginning of parapets.

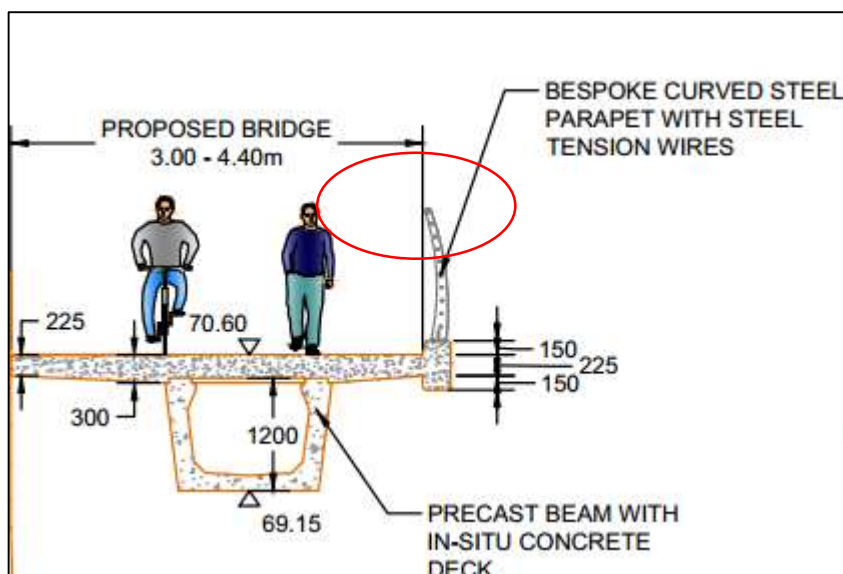
Figure 3-4 – Proposed Parapet

The design drawings show a parapet as shown below Figure 3-6. If the parapet end is not suitably transitioned/terminated into the proposed fence smoothly this may leave sections of the parapet where pedestrians may become snagged which could result in pedestrian injury.

The Designer should ensure the end of each parapet are designed to prevent any snagging on the end/ beginning of parapets.

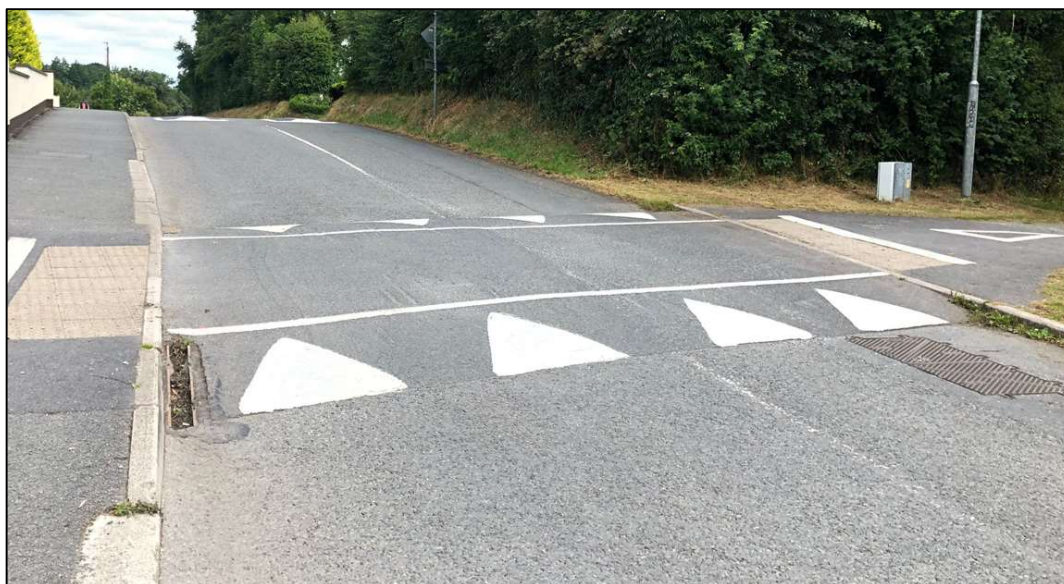
Figure 3-5 – Existing Ramp and Utility Chamber

The proposed ramp location intersects with an existing (large) utility chamber as shown in Figure 3-5 below. The drawings indicate the chamber and cover will be spread across the ramped and flat area of the table which may lead to trips and falls of pedestrians.

The Designer should ensure the ramp location adequately caters for this chamber size in the final positioning of the ramp.

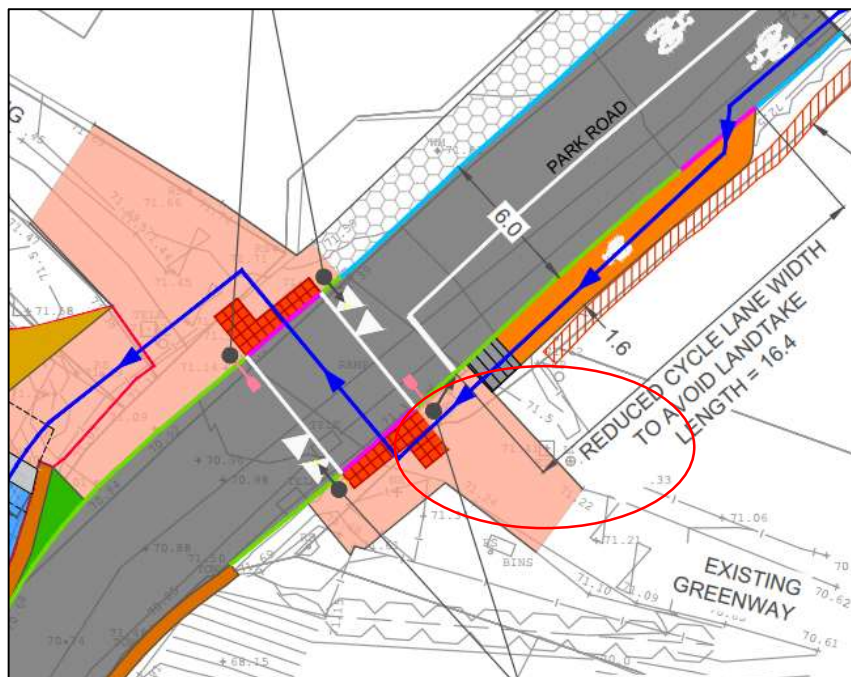
Figure 3-6 – Visibility at Shared Area

The area for cyclists entering the shared area from the cycle track as shown in **Figure 3-6** appears small. This could result in cyclists coming into conflict pedestrians and cyclists from the greenway where adequate space does not exist.

The Designer should consider extending the shared area at this location so as to reduce risk of conflict.

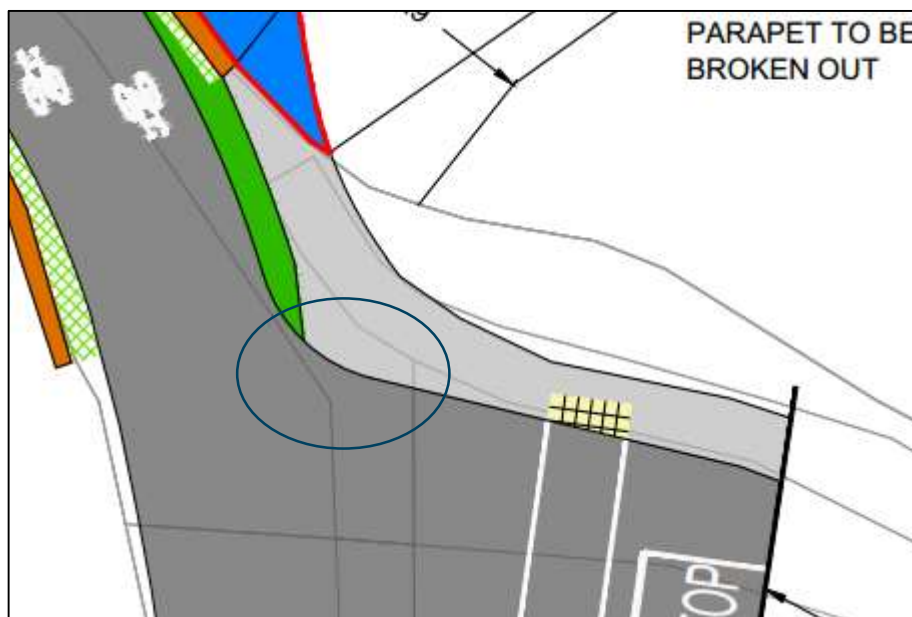
Figure 3-1 – Indicative area of chamber and footpath

The proposed footpath widening intersects with an existing utility chamber as shown in Figure 3-7 below. If the existing utility chamber is not raised and plumbed with the proposed footpath appropriately this may lead to trips and falls of pedestrians over the lid and frame of the chamber.

The Designer should ensure the chamber is catered for as part of the proposed works.

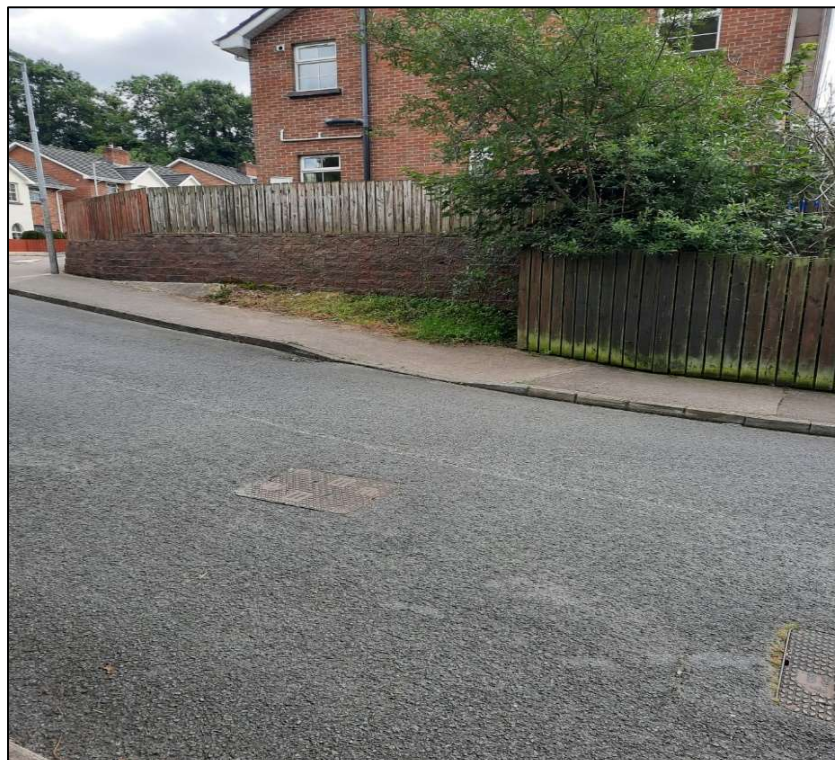
Figure 2-1 – Existing drop kerb

The proposed pedestrian crossing at Coolshannagh Walk junction south of the bridge does not take into account the existing drop kerb along Coolshannagh Walk. The existing crossing may lead to visually impaired road users inadvertently walking onto the carriageway at this location where they could be struck by vehicles.

Recommendation: The existing dished kerb and adjacent footpath should be removed as part of the proposed works.

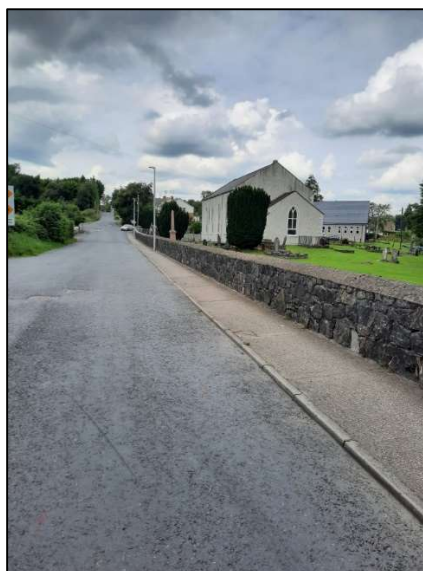
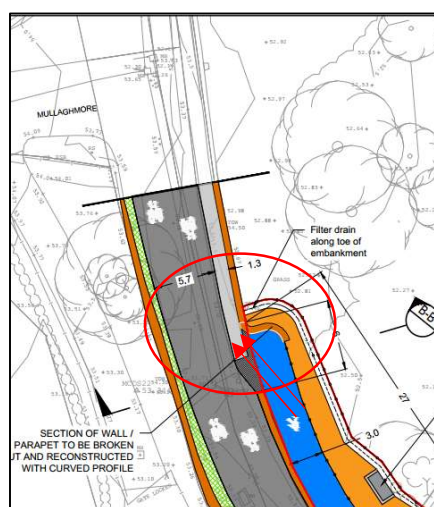
Figure 2-3 – Existing Footpath

The proposed footway is over 3m along the bridge and then narrows suddenly to 1.3m at the existing footpath as shown in Figure 2-3. If pedestrians meet along this section of existing footpath or people walk side-by-side across the bridge, it is likely the person on the LHS / outside would have to step onto the carriageway and may come into conflict with traffic coming from the north.

Recommendation: The Designer should investigate measures to gradually reduce the footpath over a longer distance and reduce the chance of people stepping onto the road due to the sudden narrowing.

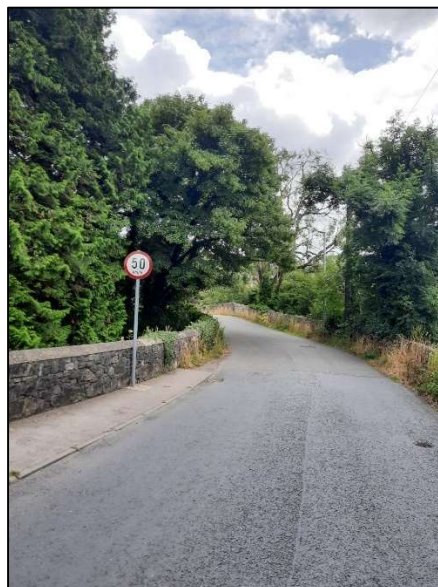
Figure 2-3 – Overgrown tree

The northern approach to the Ballyalbaney bridge has an overgrown tree that restricts sight lines for approaching vehicles to the bridge. This may lead conflict due to the restricted sight lines.

Recommendation: The existing tree should be curtailed as part of the proposed works.

2.3	Yes	<p>Yes.</p> <p>Monaghan CC will be notified of the recommendation as it may be obstructing sightlines in the existing situation.</p> <p>This tree may need to be removed for construction of the embankment.</p>		Yes

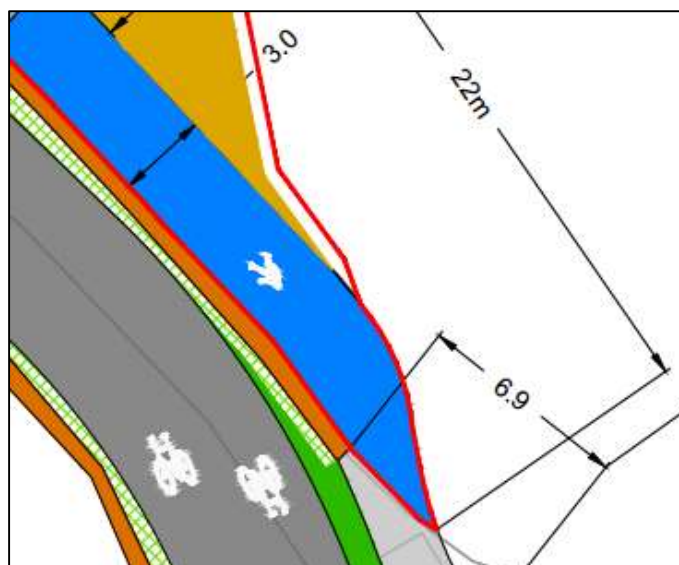
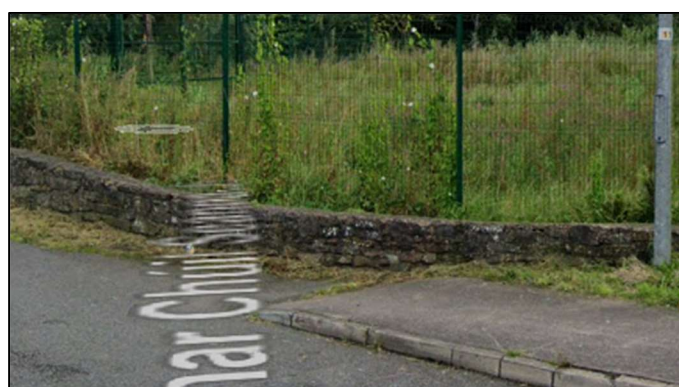
Figure 2-4 – Proposed end of wall/ Parapet

The proposed design shows an exposed end to the existing wall/parapet. The open-end wall/ parapet at this location poses a risk increased injury severity from errant vehicles travelling from the south. The risk is exacerbated by the downgrade and curved alignment that exists from the south.

Recommendation: The Design Team should investigate measures to negate the risk such as curving the wall similar to the existing arrangement.

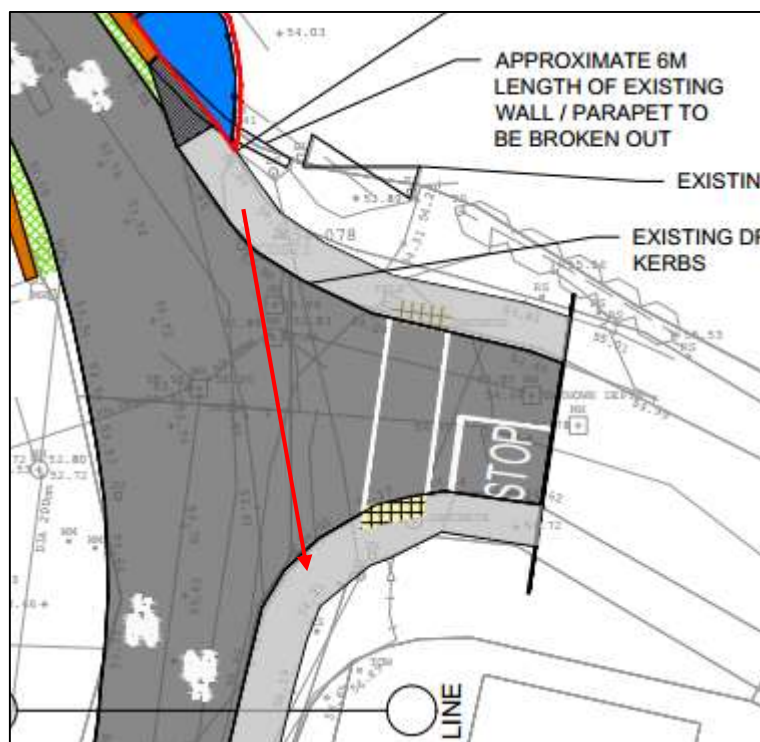
Figure 2-6 – Desire Line

The proposed pedestrian crossing at Coolshannagh Walk Junction does not appear to be along the natural desire line for pedestrians. There is a risk of slips, trips and falls where adequate provision is not made for the natural desire line. Additionally, where provision is not adequate, some may choose to walk on the trafficked lanes where they may be at risk of coming into conflict with traffic.

Recommendation: The proposals should ensure there is adequate provision along the natural desire line in terms of tactile paving and dropped kerbs, to ensure vulnerable road users can safely travel across the site.

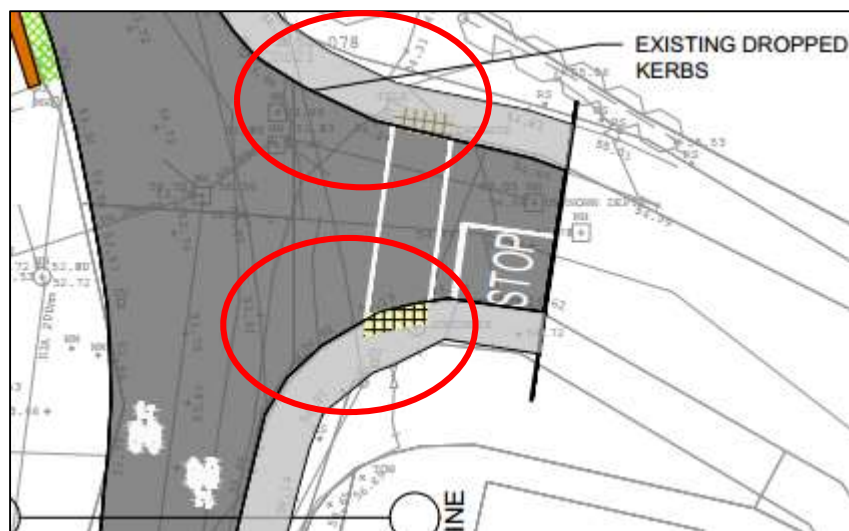
Figure 2-7 – Coolshannagh Walk Junction Radii Size

The existing/proposed radius appears large which allows vehicles to enter and exit Coolshannagh Walk Junction at higher speeds. The junction will be more challenging to pedestrians to cross if they follow the desire line identified in problem 2.5 above. This could lead to conflict between vulnerable road users and vehicles.

Recommendation: The Designer should review the radius size and reduce where possible in conjunction with providing for the natural desire line noted in 2.5 above.

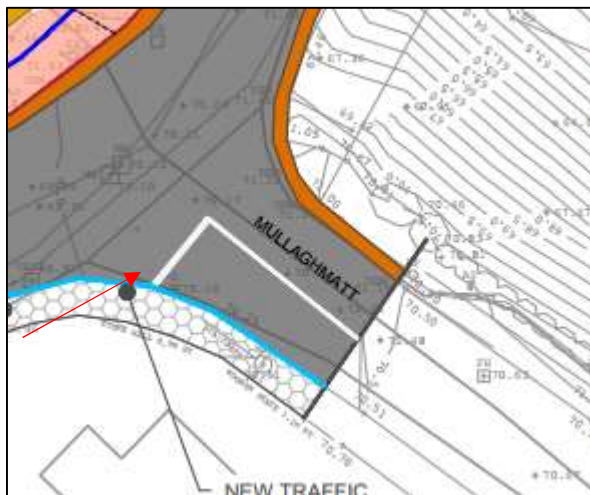
Figure 2-8 – Mullaghmatt Road

The proposed stop line position extends into the opening of the junction. If vehicles travelling north/south from Park Road enter the junction to travel east on Mullaghmatt Road, they may be restricted by waiting vehicles at the stop line on Mullaghmatt Road. This may lead to shunt collisions between vehicles as a result of blockages of the Park Road and the junction.

Recommendation: The Designer should ensure the stop line is set back to allow for access for vehicles onto Mullaghmatt Road from Park Road.

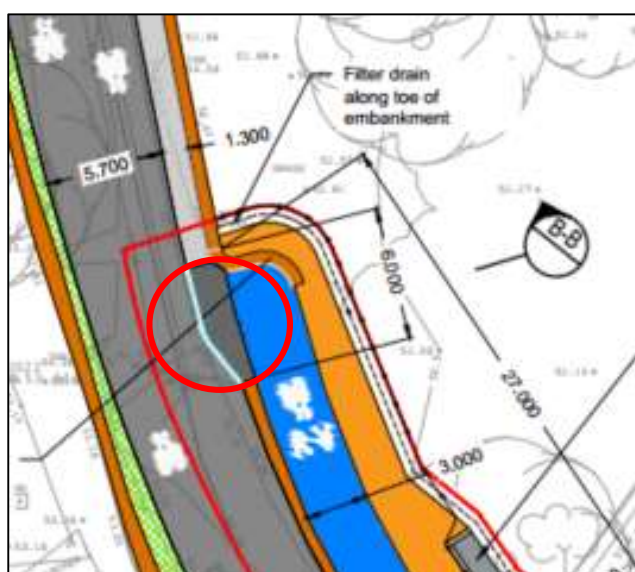
Figure 4-1 – Proposed Drop Kerb for Cyclists

The proposed drop kerb as shown in figure 4-1 as a light blue polyline runs parallel to the carriageway lane. Cyclists travelling south are required to enter the proposed ramp at an angle to the proposed drop kerb. If the kerb is not flush or suitably profiles to the proposed pavement level this could create a lip which cyclists are required to navigate over. Cyclists if entering at high speeds could slip along the raised kerb which could lead to slips or falls of cyclists trying to enter the shared area.

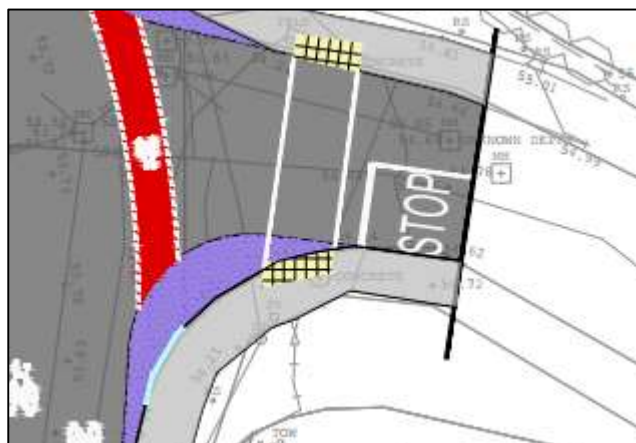
Figure 4-2 – Proposed Drop Kerb for Cyclists

The proposed dropped kerb at the location in figure 4-2 encourages cyclists to enter onto the footpath. The layout may create confusion for cyclists and lead to conflict between pedestrians and cyclists.

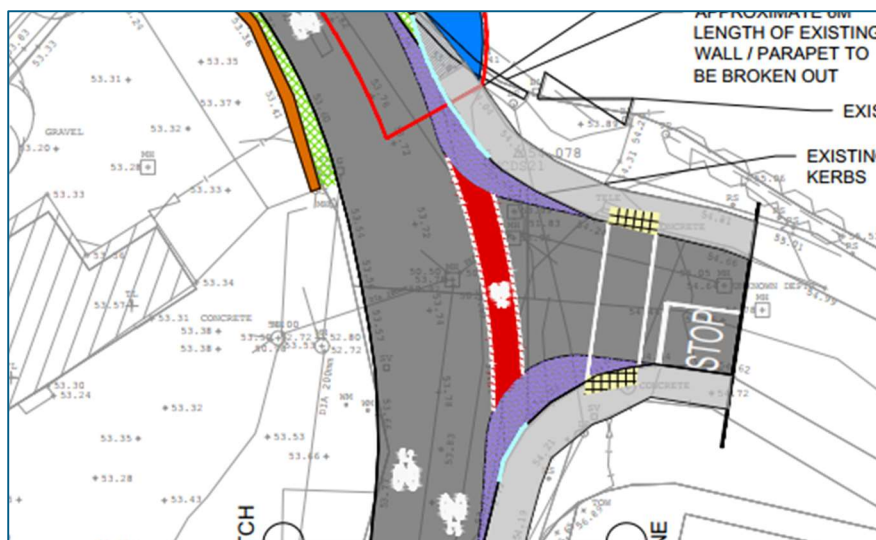
Figure 4-3 – Proposed online cycle lane

The proposed online cycle track appears to start and end abruptly shortly at the junction. It appears that cyclists may abruptly enter the carriageway which is not expected by drivers who may be turning into Coolshannagh Walk. At the south of the cycle track, there is an abrupt end which abuts the footpath that may lead to cyclist abruptly merging to the road where conflict may arise.
