**PROPOSED DEVELOPMENT
ACTIVE TRAVEL ROADWAY
MONAGHAN
MONAGHAN CO. COUNCIL**

**DBFL
CONSULTING ENGINEERS**

An investigation of sub soil conditions in the various areas of the new development has been carried out by IGSL for DBFL, Consulting Engineers, on behalf of Monaghan County Council.

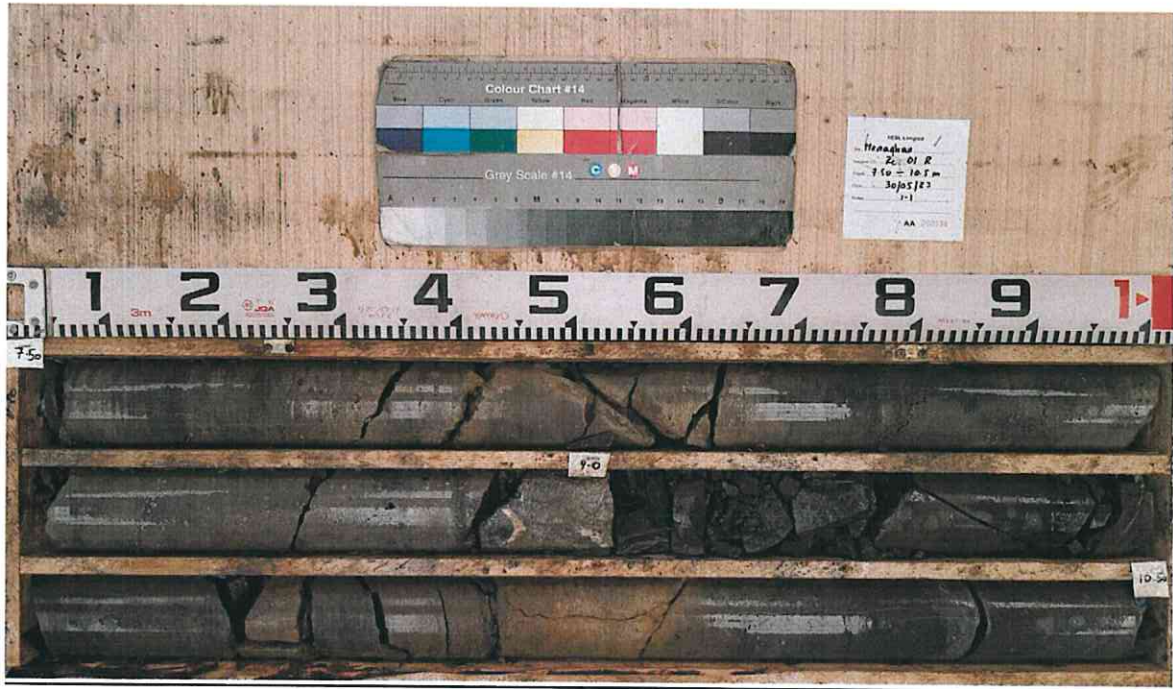
RC01R – Box 1 of 1 – 7.50-10.50m

Bedrock was noted at 7.50 metres and 3.00 metres of solid core was recovered. Strong to very strong blue grey fine grained LIMESTONE has been identified by the geologist.

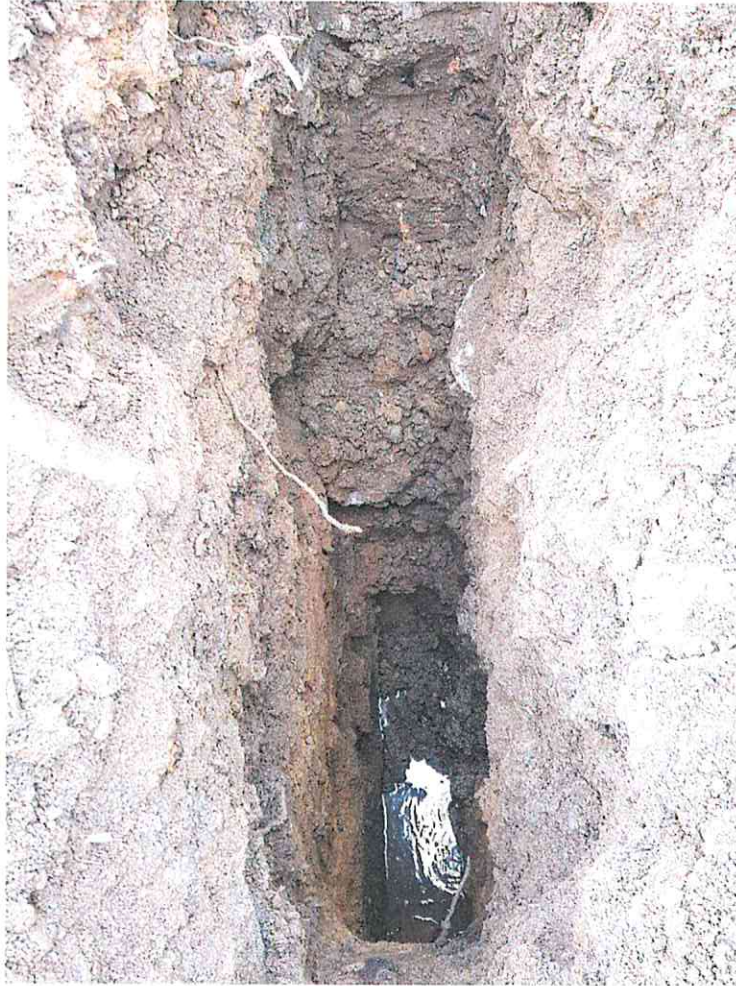
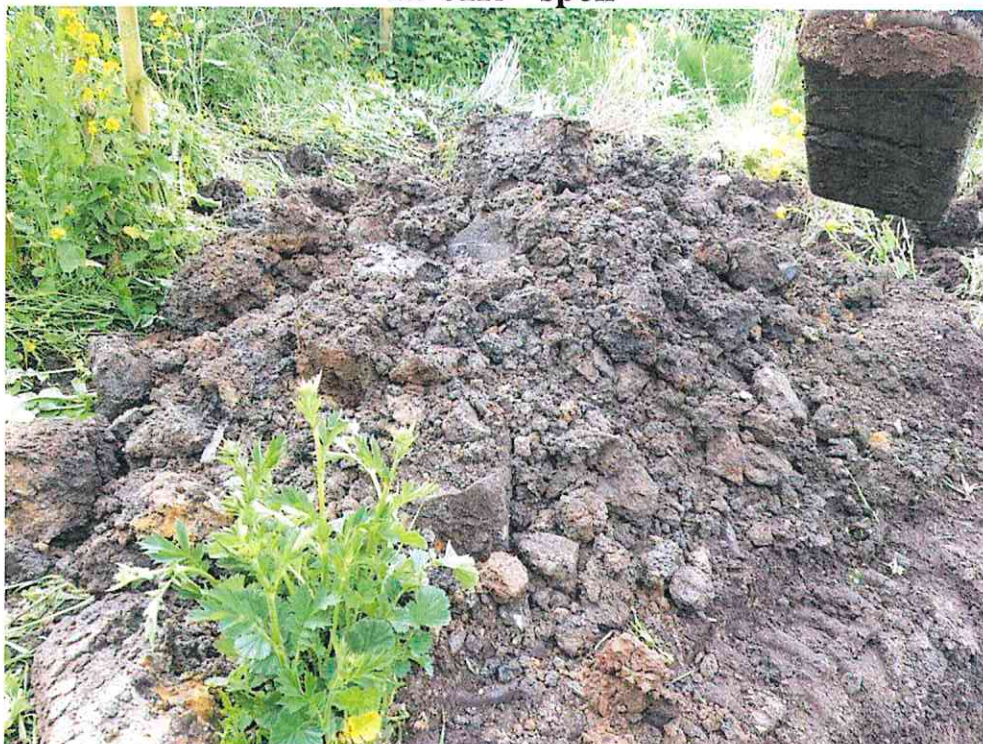
TRIAL PIT PHOTOGRAPHY RECORD
TP 01R

TP 01R – spoil

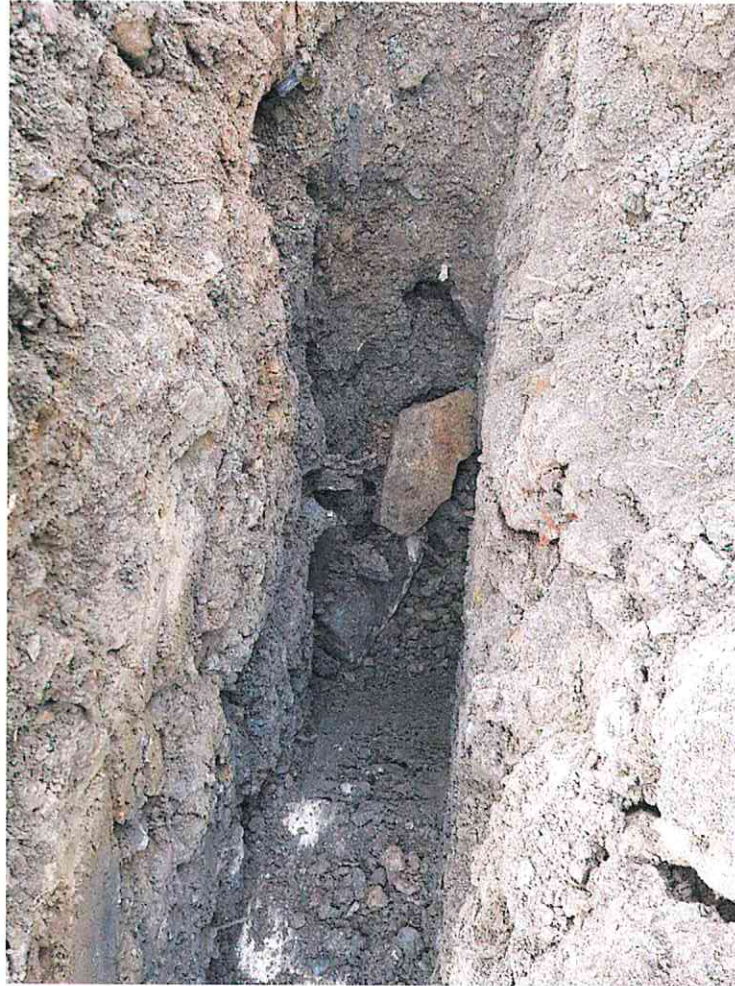
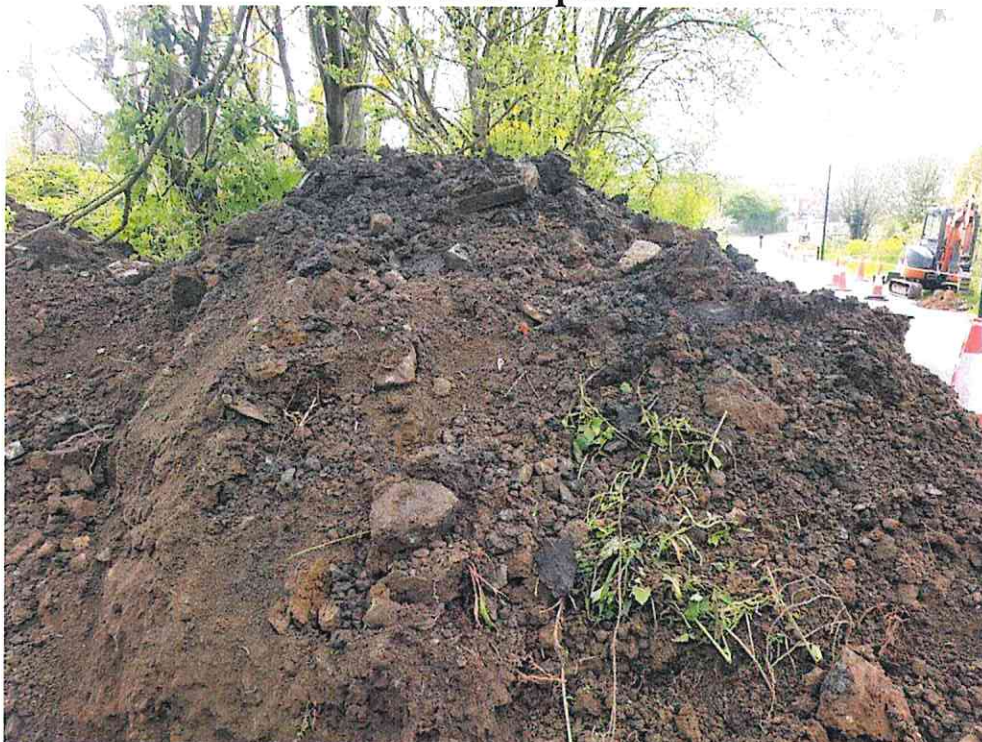
TRIAL PIT PHOTOGRAPHY RECORD
TP 02R

TP 02R – spoil

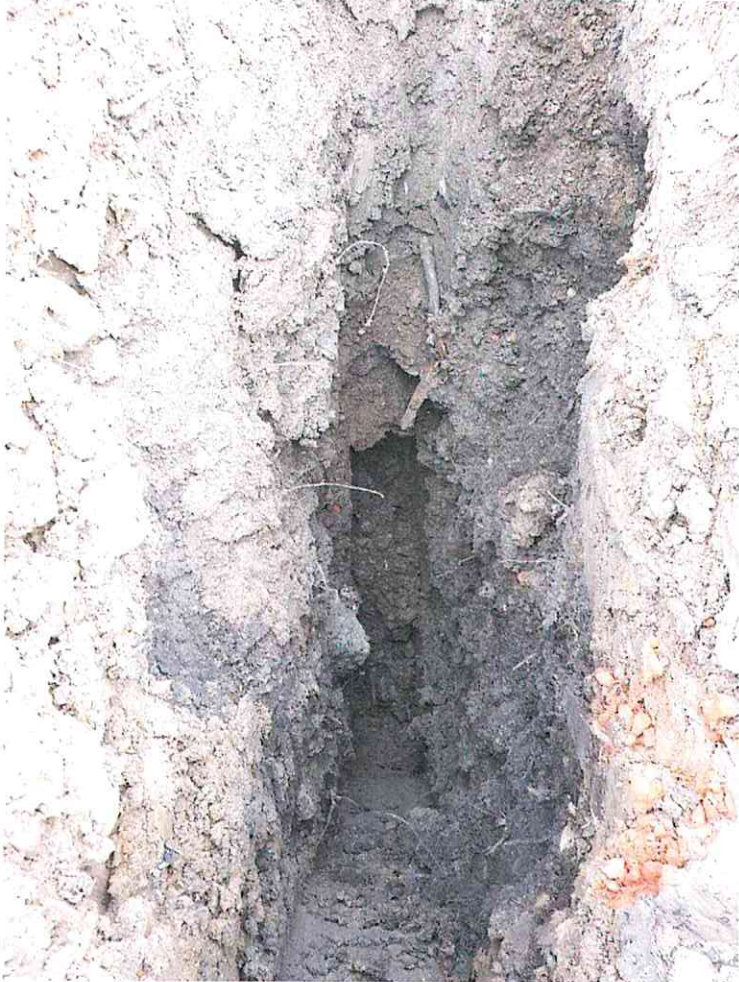
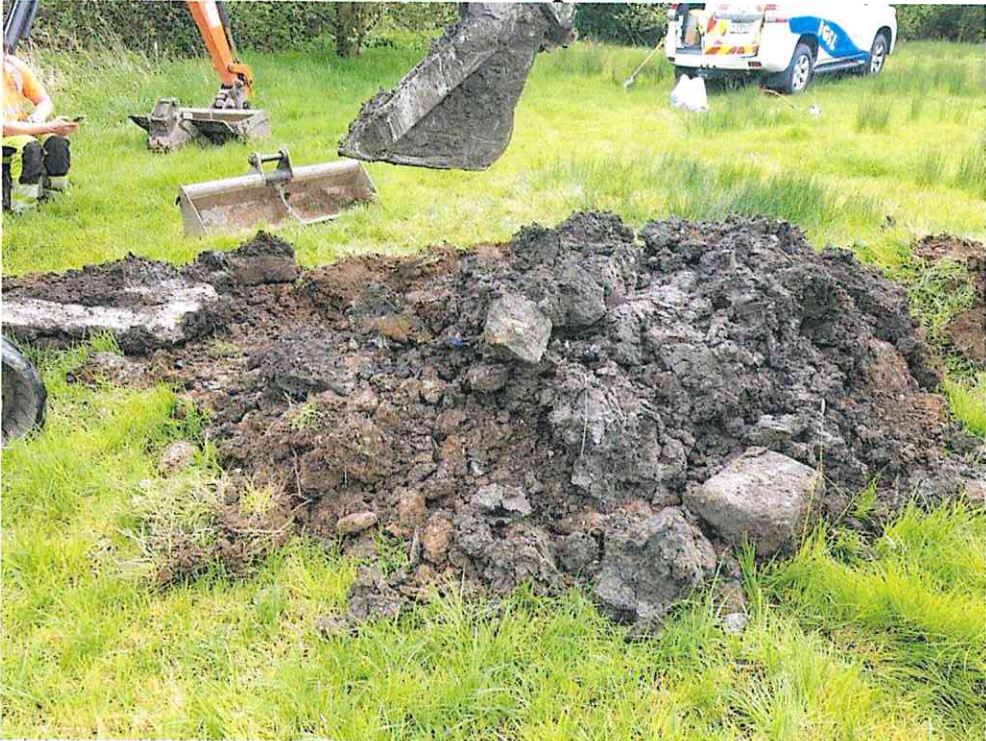
TRIAL PIT PHOTOGRAPHY RECORD
TP 03R

TP 03R – spoil

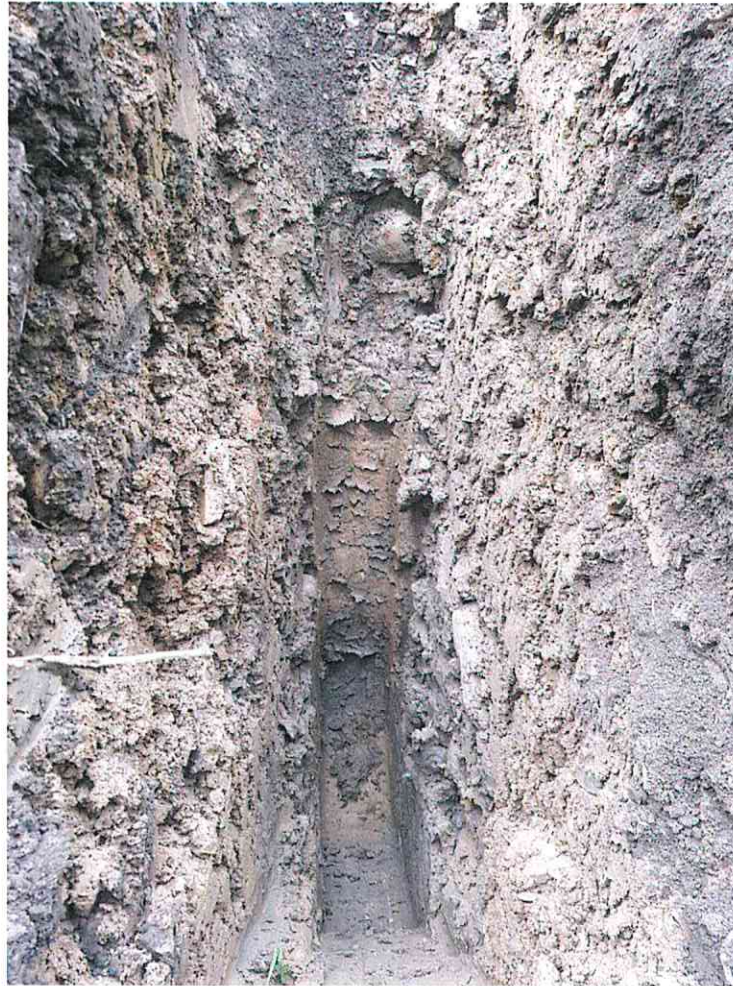
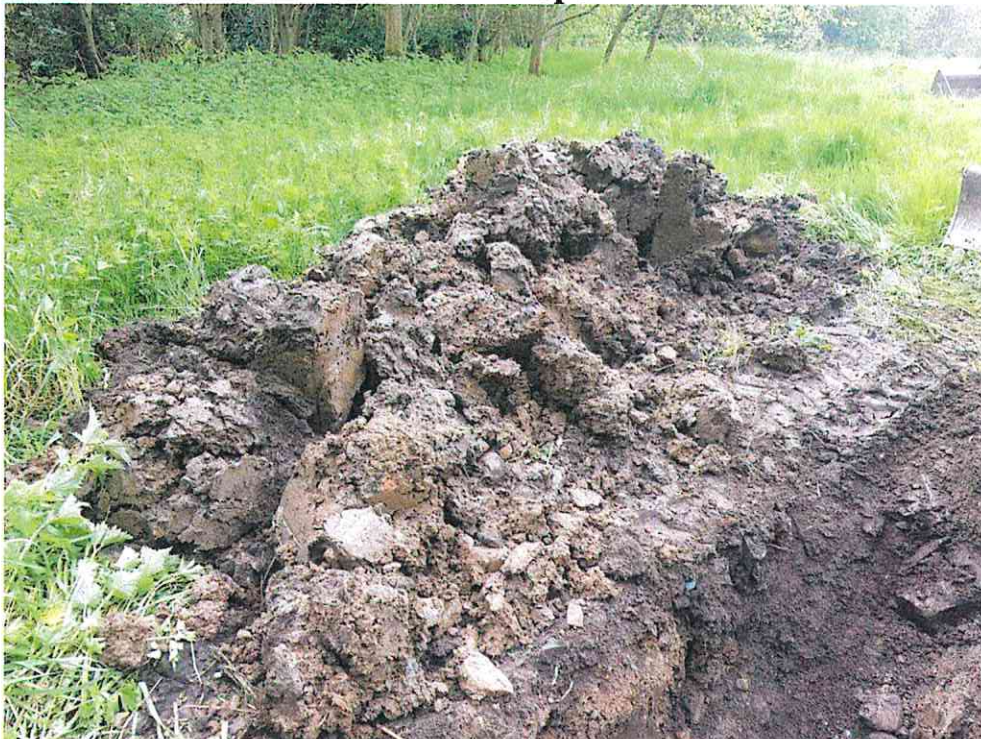
TRIAL PIT PHOTOGRAPHY RECORD
TP 04R

TP 04R – spoil

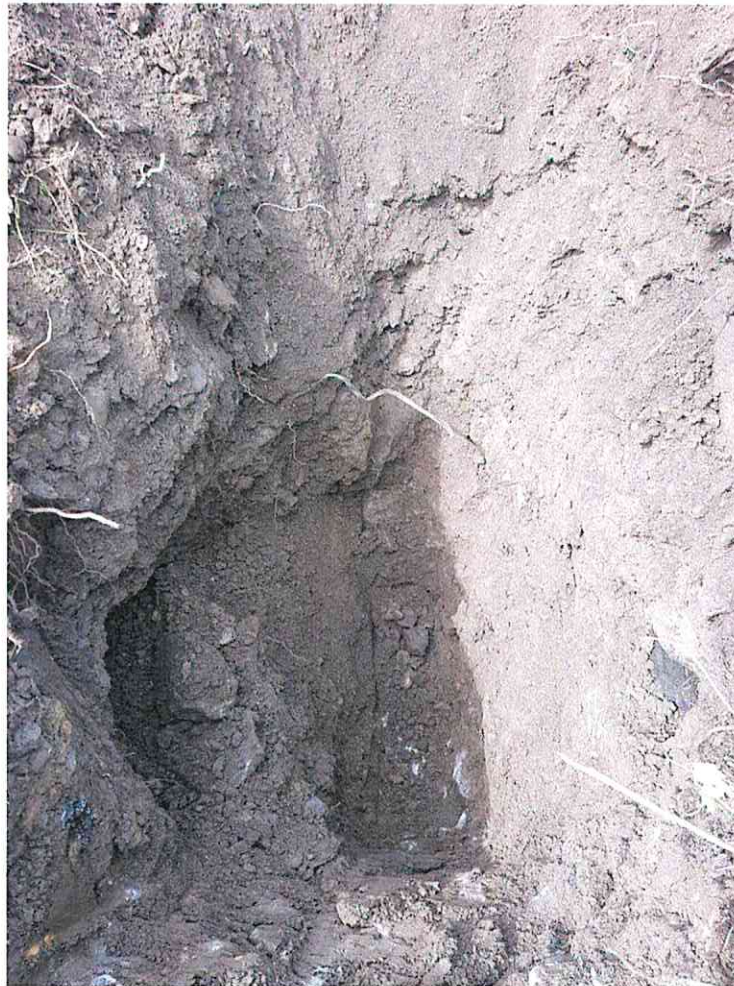
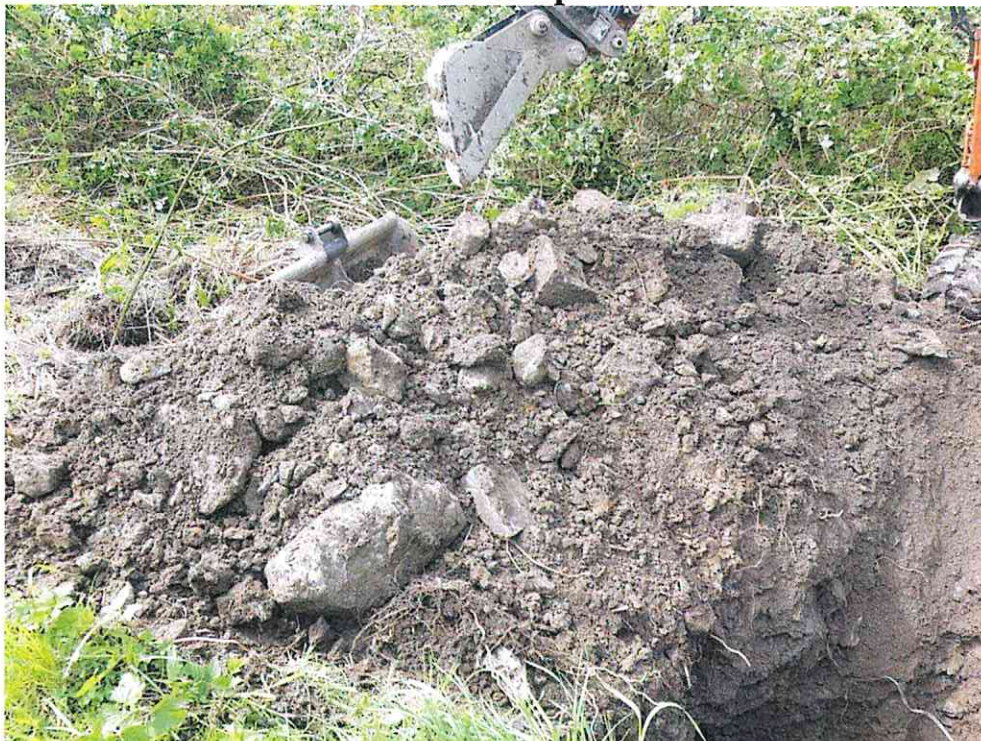
TRIAL PIT PHOTOGRAPHY RECORD
TP 05R

It should be noted that an elevated level of Total Organic Carbon was identified in a sample of MADE GROUND from TP05R.

TP 05R – spoil

Construction in this area will be similar to that outlined in Area A. The reduced thickness of MADE GROUND in this area is noted and the removal of this material prior to road construction may be an economic option.

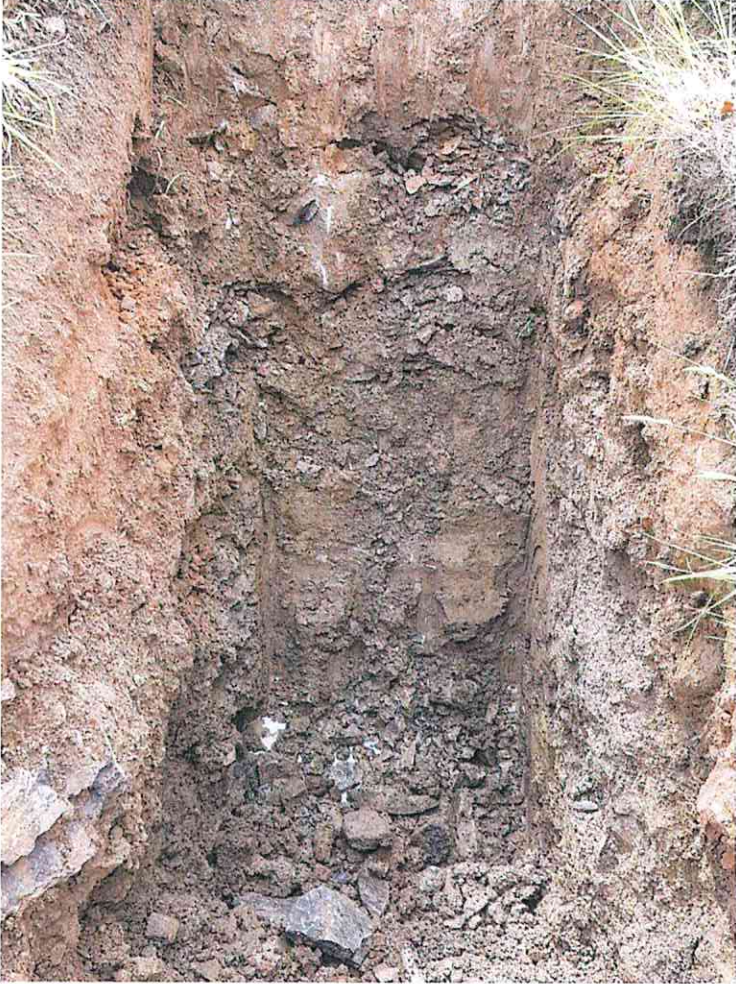
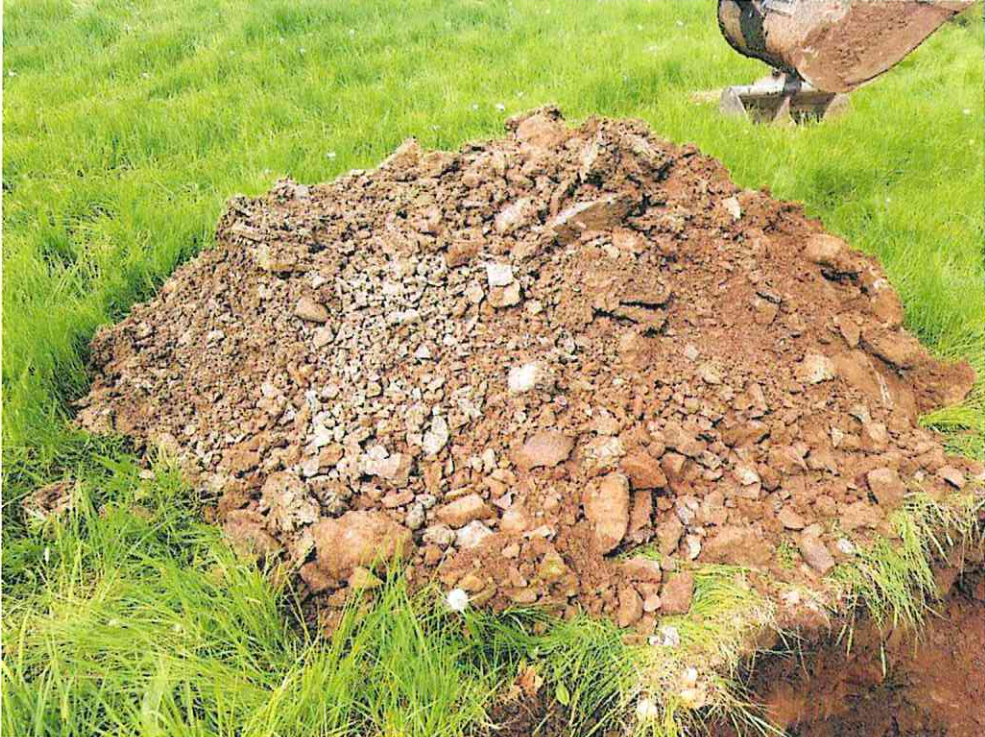
TRIAL PIT PHOTOGRAPHY RECORD
TP 06R

TP 06R – spoil

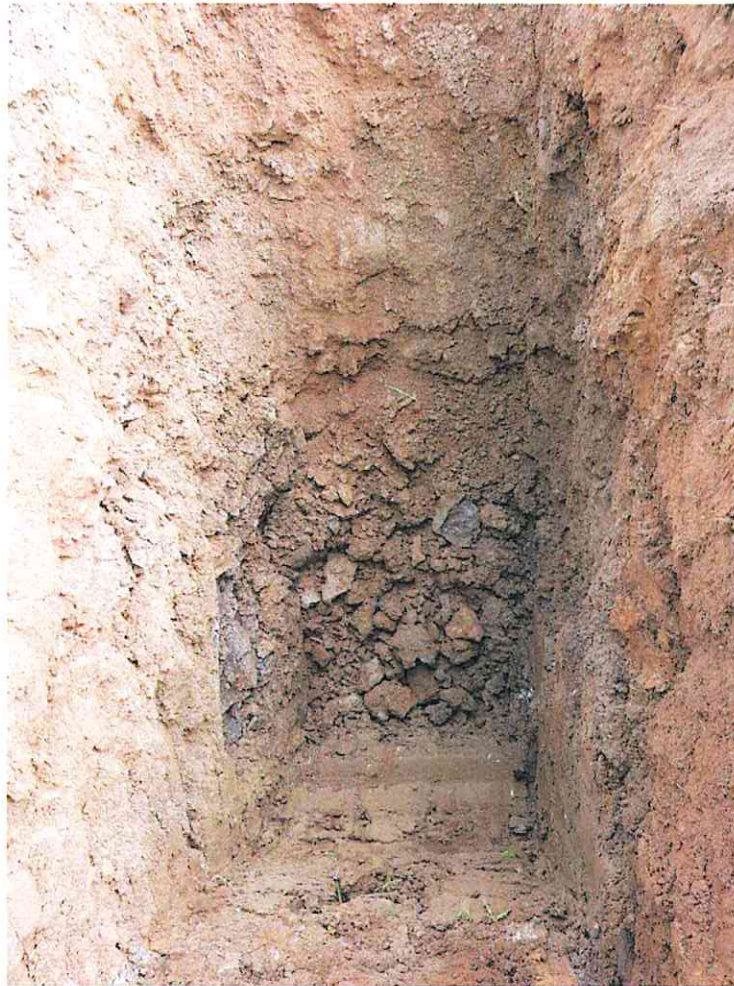
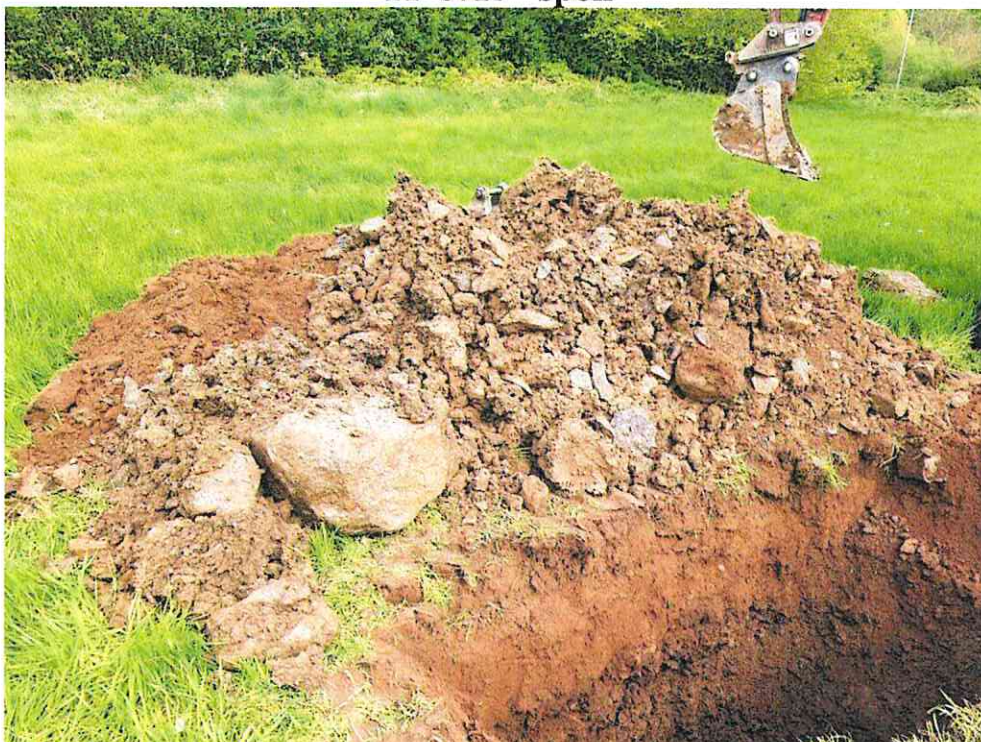
TRIAL PIT PHOTOGRAPHY RECORD
TP 07R

TP 07R – spoil

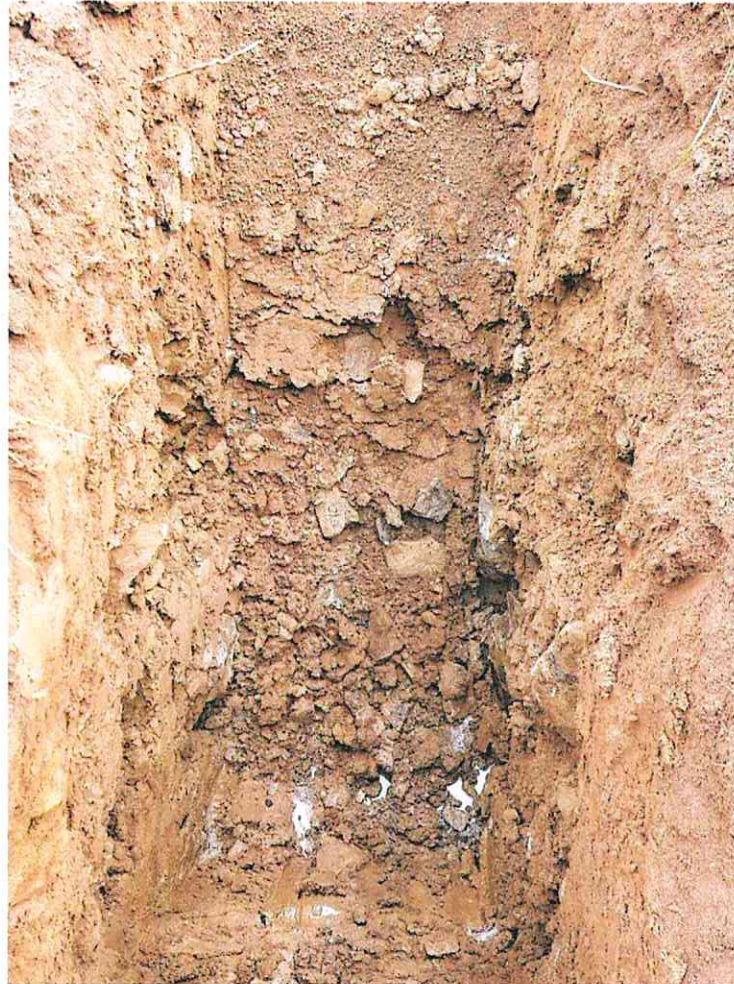
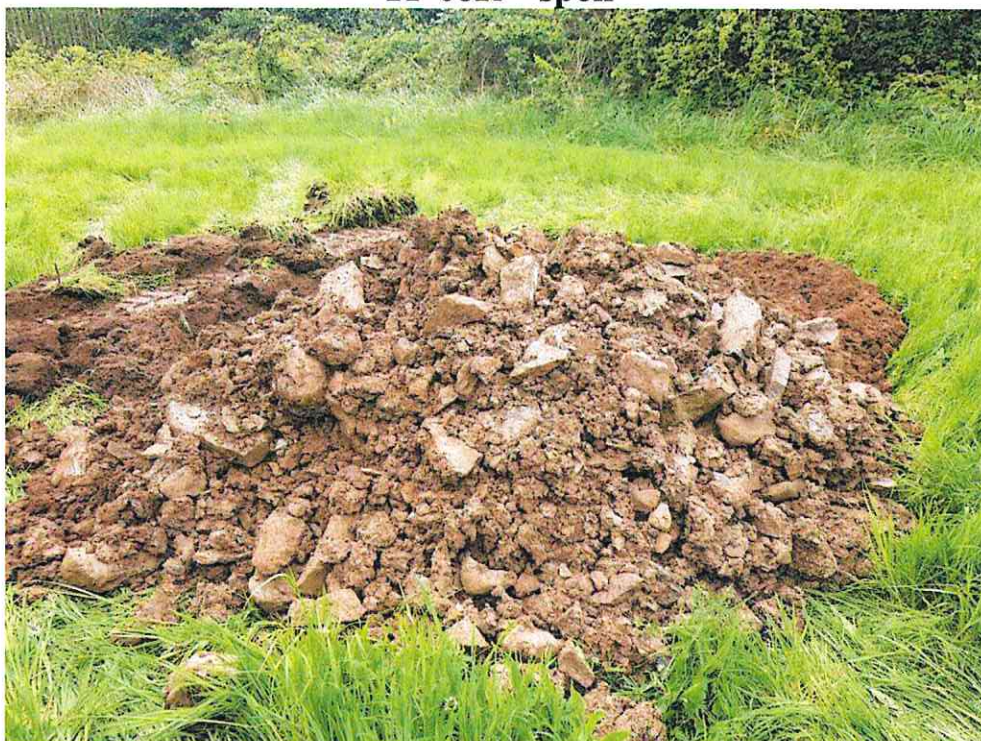
TRIAL PIT PHOTOGRAPHY RECORD
TP 08R

TP 08R – spoil

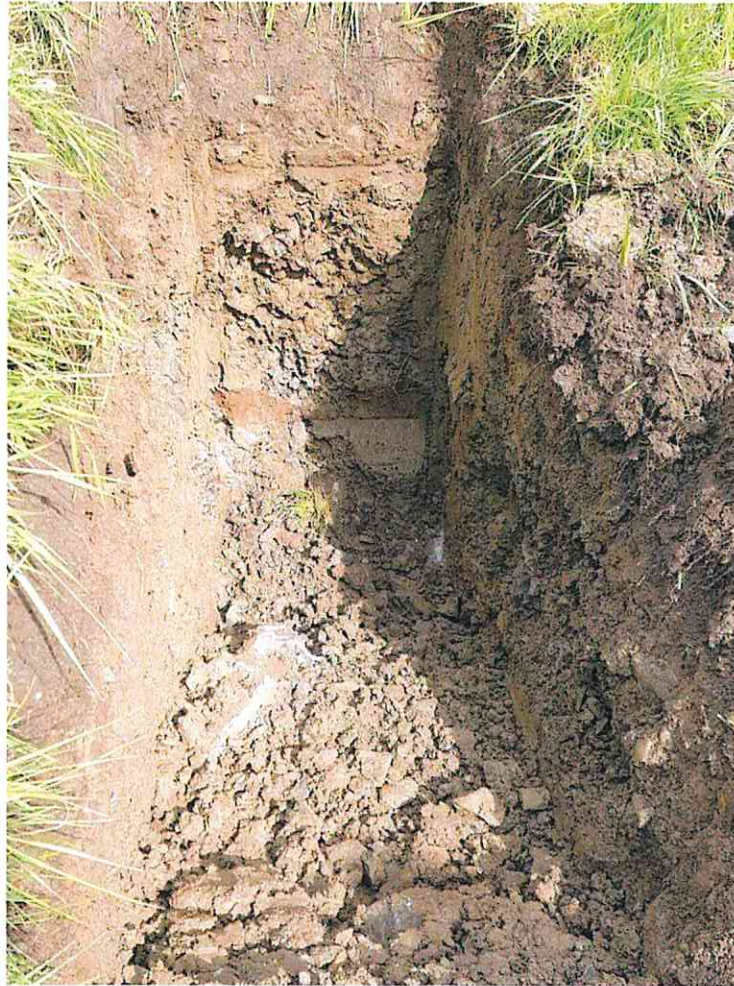
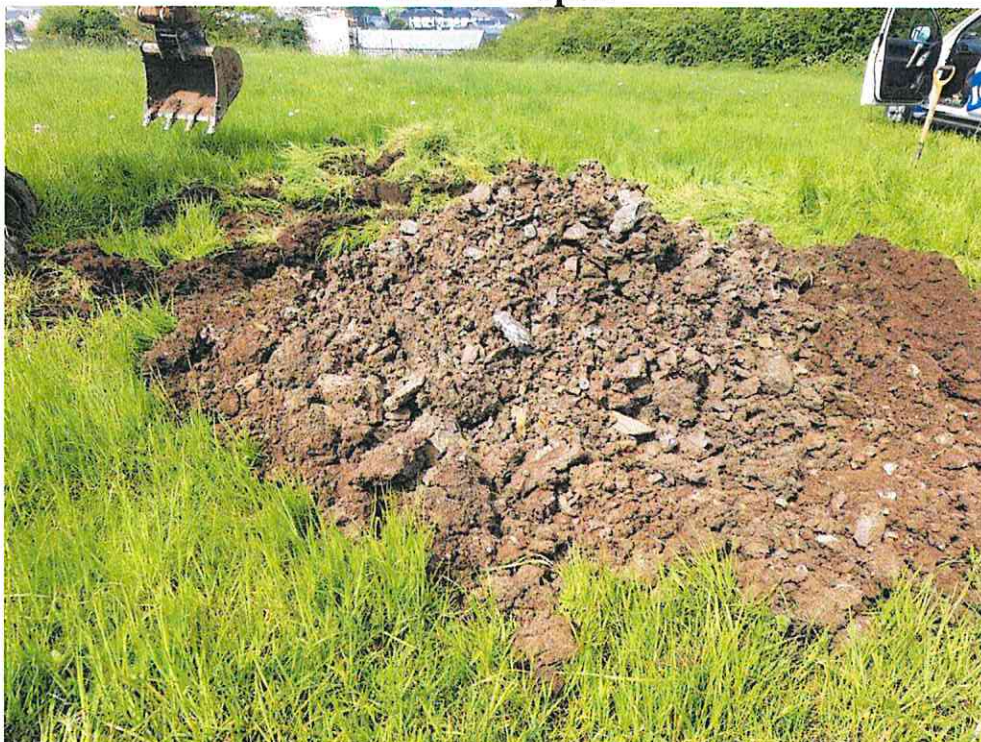
TRIAL PIT PHOTOGRAPHY RECORD
TP 09R

TP 09R – spoil

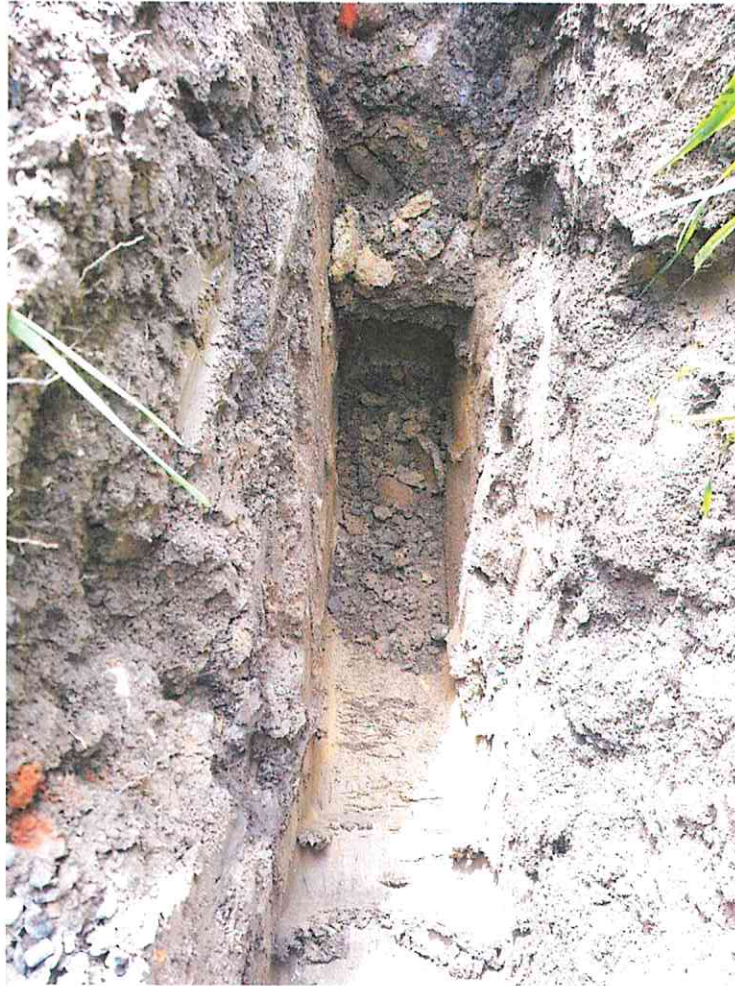
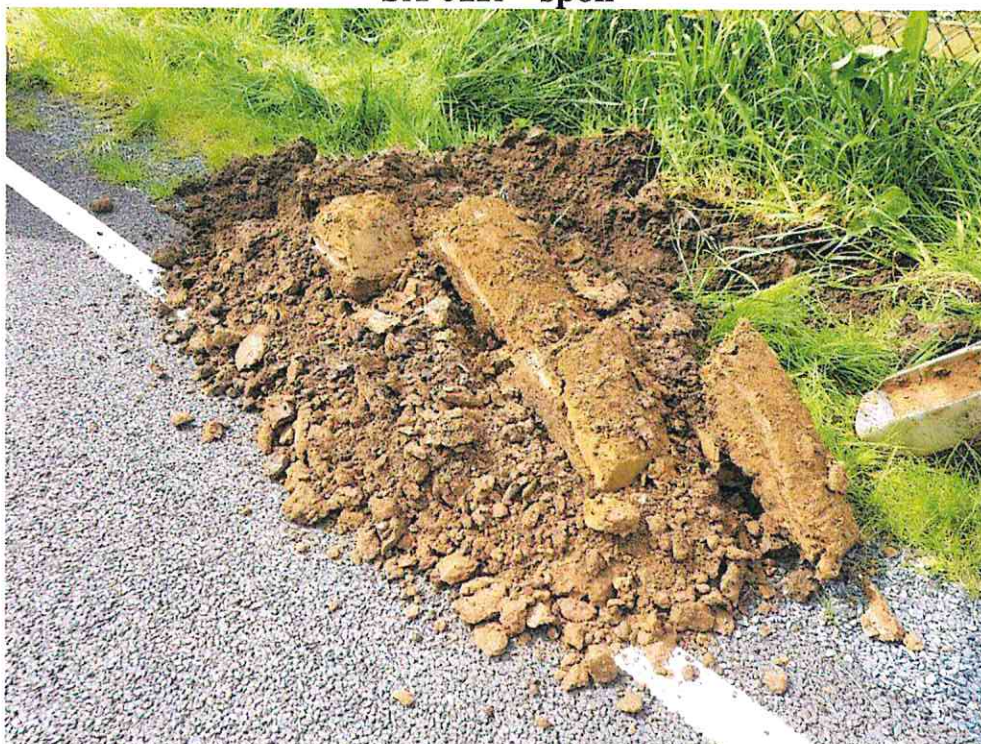
TRIAL PIT PHOTOGRAPHY RECORD
SA 01R

SA 01R – spoil

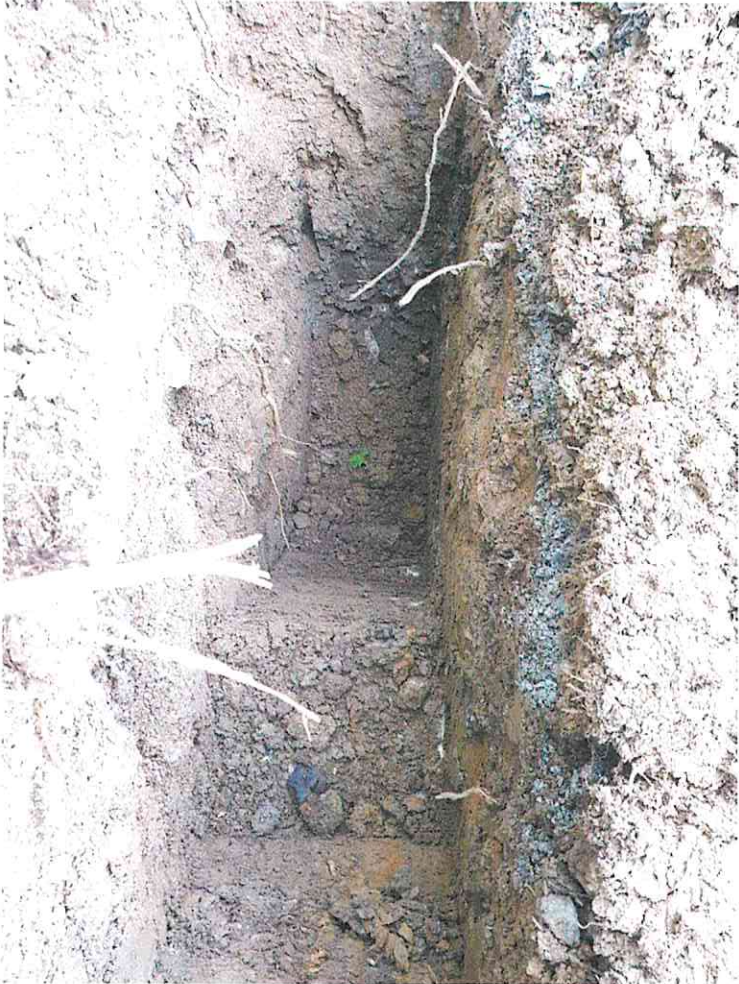
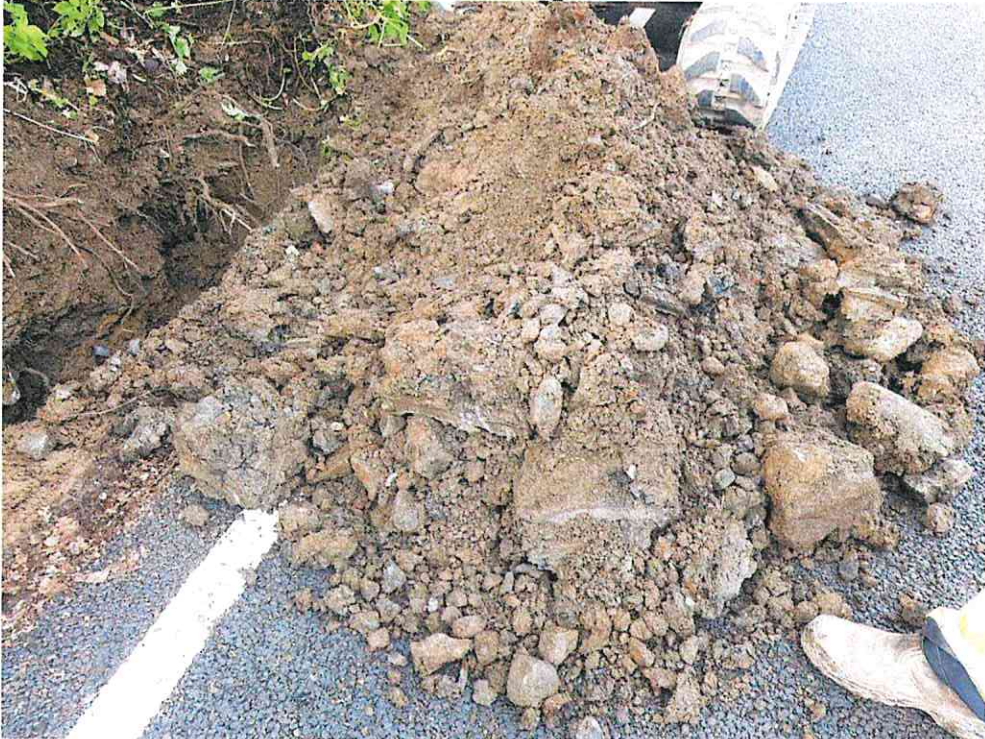
TRIAL PIT PHOTOGRAPHY RECORD
SA 02R

SA 02R – spoil

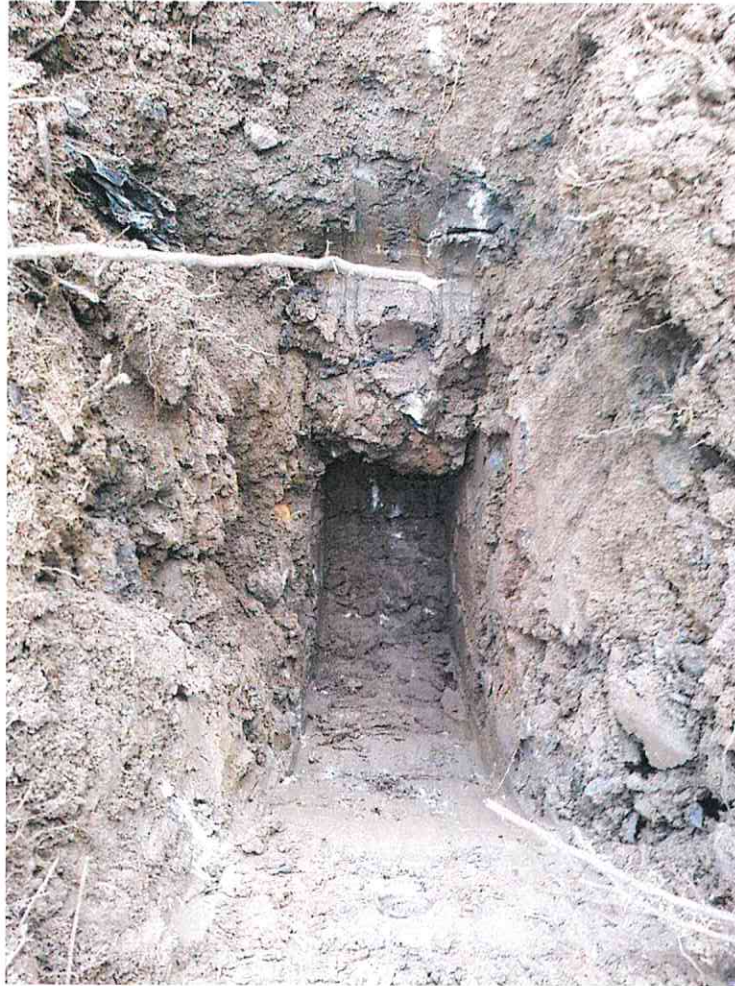
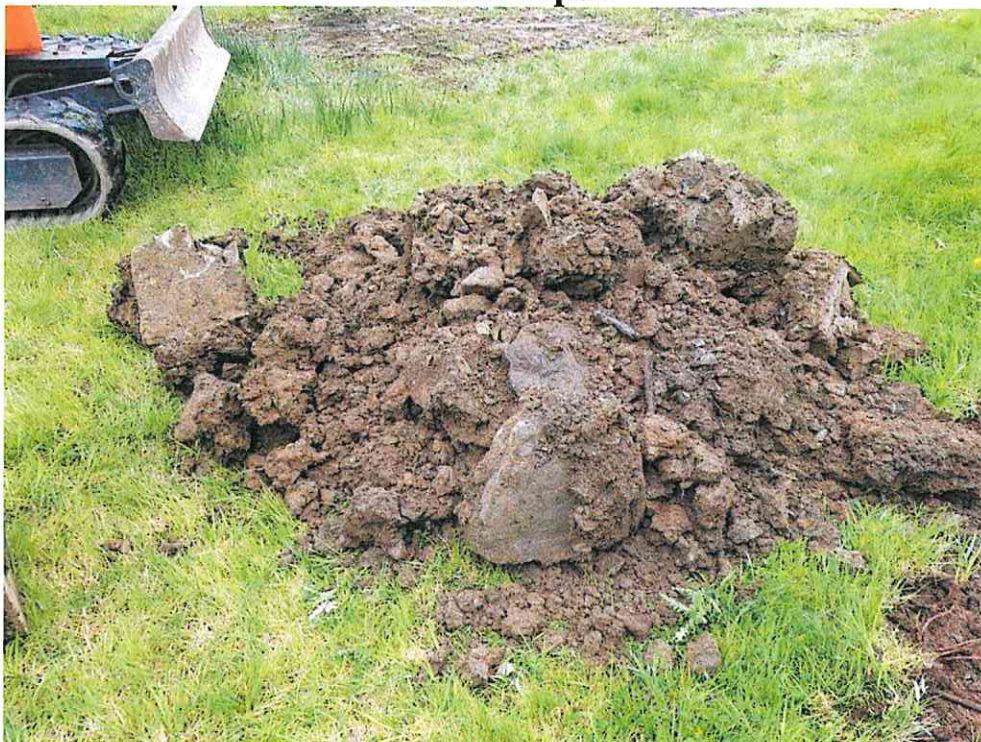
TRIAL PIT PHOTOGRAPHY RECORD
SA 03R

SA 03R – spoil

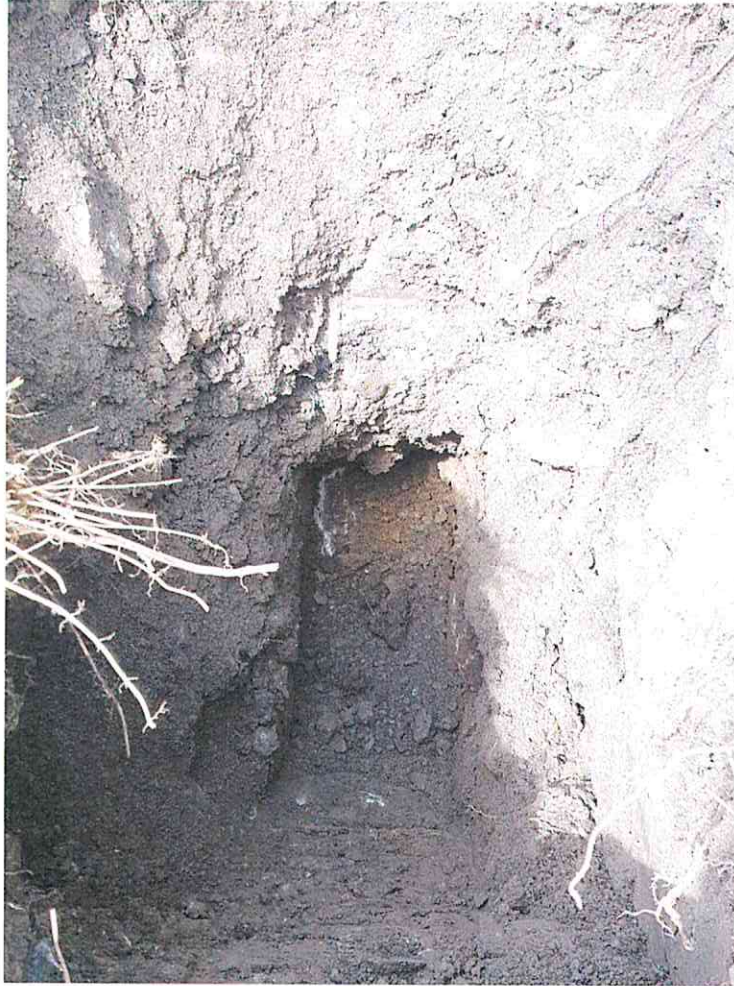
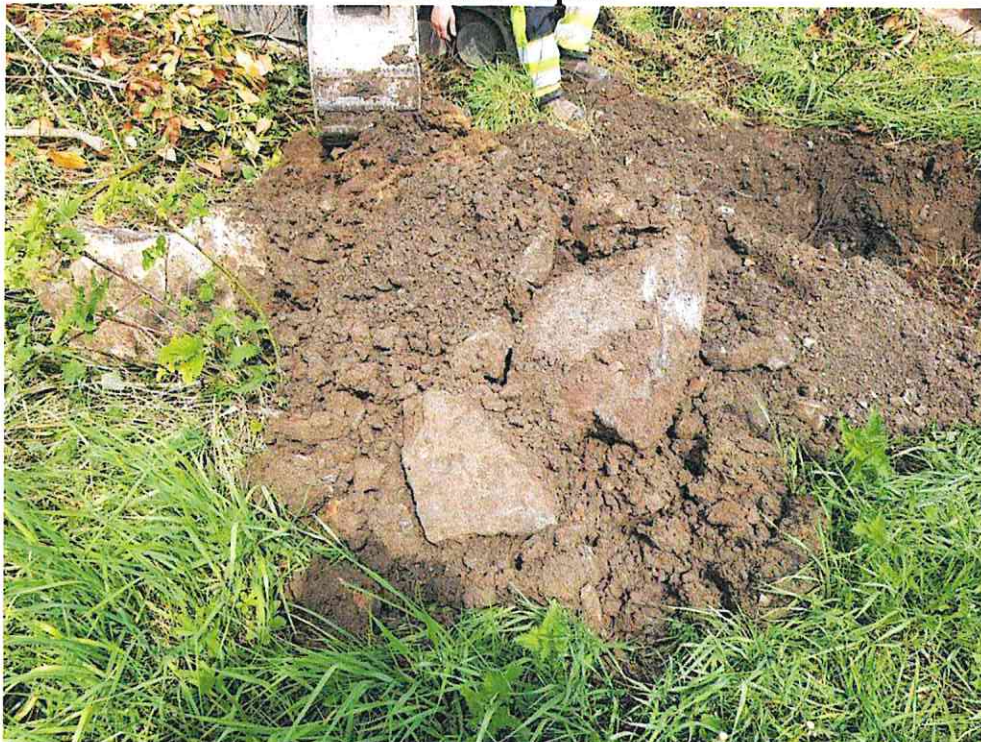
TRIAL PIT PHOTOGRAPHY RECORD
SA 04R

SA 04R – spoil

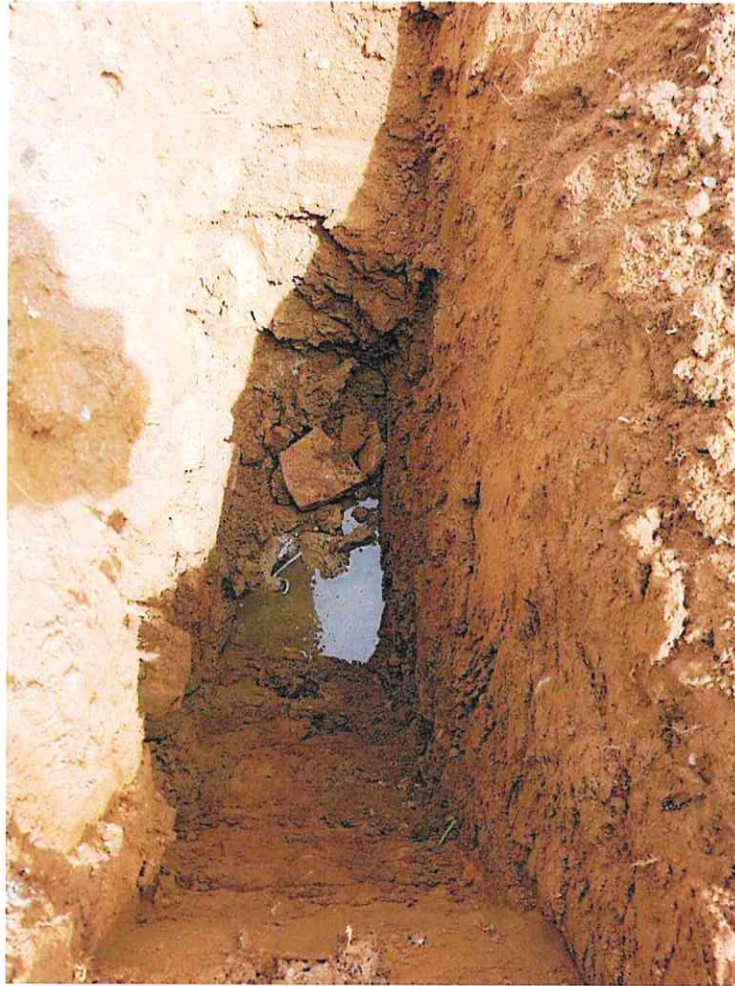
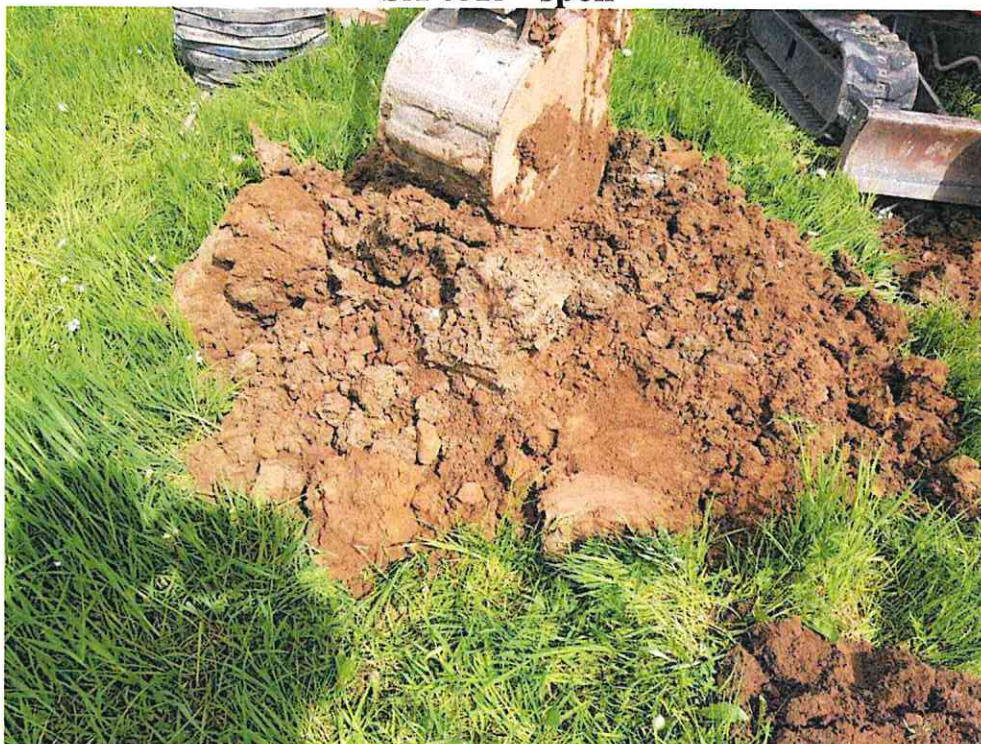
TRIAL PIT PHOTOGRAPHY RECORD
SA 05R

SA 05R – spoil

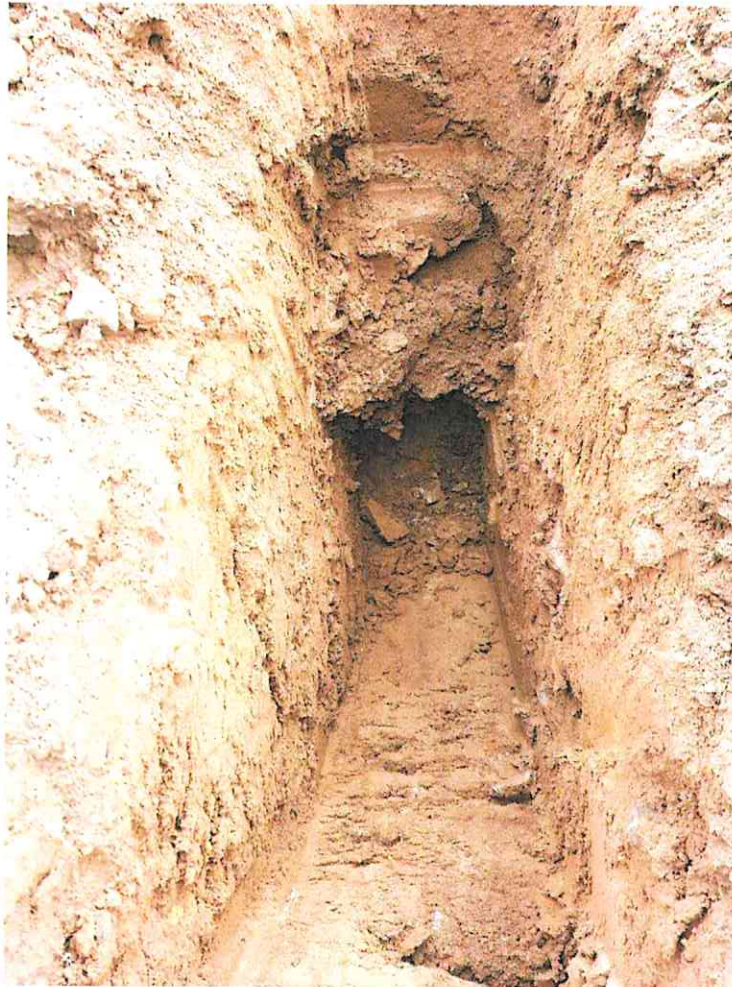
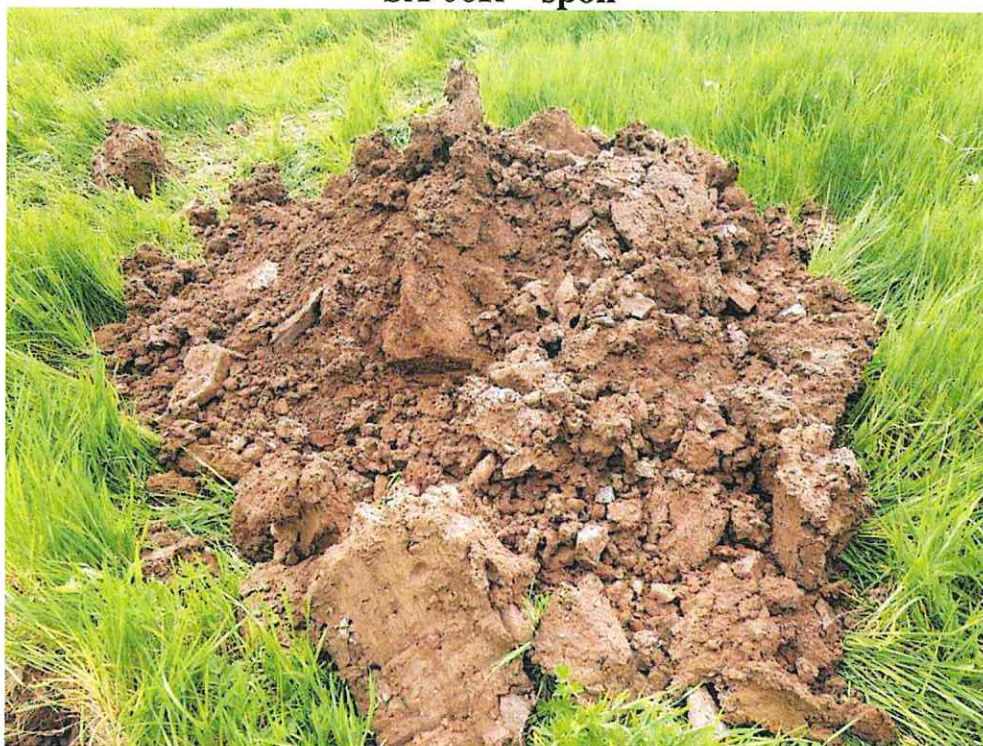
TRIAL PIT PHOTOGRAPHY RECORD
SA 06R

SA 06R – spoil
