**PROPOSED DEVELOPMENT
ACTIVE TRAVEL ROADWAY
MONAGHAN
MONAGHAN CO. COUNCIL**

**DBFL
CONSULTING ENGINEERS**

An investigation of sub soil conditions in the various areas of the new development has been carried out by IGSL for DBFL, Consulting Engineers, on behalf of Monaghan County Council.

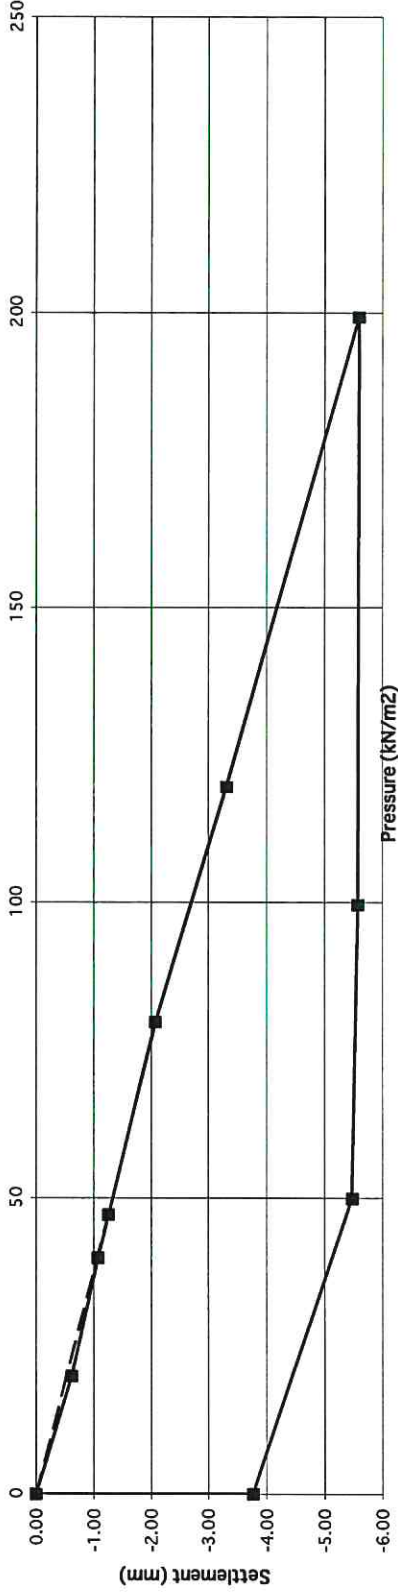
PLATE TEST REPORT SHEET (F3.1)		Applied Pressure/Settlement Curve	
Reference No.	R144697	Description of soil under test (natural soil, placed fill, sub-base)	MADE GROUND (sandy gravelly clay, angular cobbles)
Contract	Monaghan Active Travel		
Test No.	PBT01 - load	Easting (m)	Northing (m)
Location	TP01R		
Depth	0.5m bgl	Ground Level (mOD)	Sample Ref No.
Client	DBFL		
Plate Diameter:	300 mm	Depth	N/A
Test Method	BS 1377: Part 9: 1990 Test4 - Incremental Loading Test		
Technician	J.Reider	0.00 m bgl	
Authorised by			
Date	02/05/2023

Gradient at 1.25 mm settlement intersection = 38 Modulus of subgrade reaction = 17 MPa/m Correction factor applied = 0.46 as per HD 25-26/10		Equivalent CBR value in accordance with NRA HD25-26/10 1.3 %

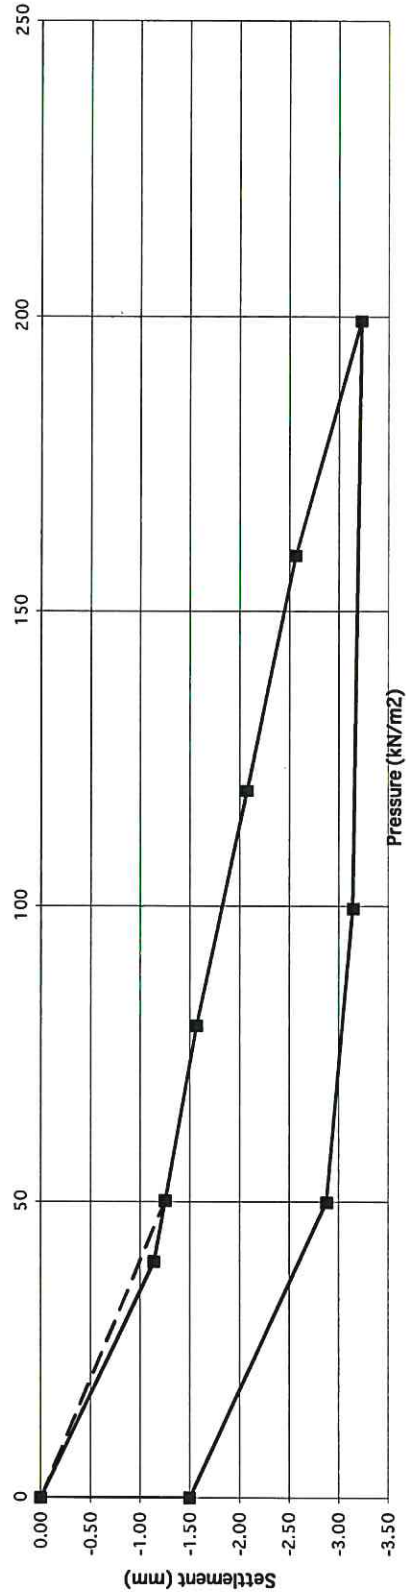
Test No. PBT02 - Reload	Location TP02R		
Depth 0.5m bgl	Client DBFL	Easting (m)	
Plate Diameter: 300 mm	Technician J. Reder	Northing (m)	
Test Method BS 1377: Part 9: 1990 Test4 - Incremental Loading Test	Authorised by J. Reder	Ground Level (mOD)	
Date 02/05/2023		Sample Ref No. N/A	
		Depth 0.00 m bgl

Gradient at 1.25 mm settlement intersection = 40 Modulus of subgrade reaction = 18 MPa/m Correction factor applied = 0.46 as per HD 25-26/10		Equivalent CBR value in accordance with NRA HD25-26/10 1.5 %

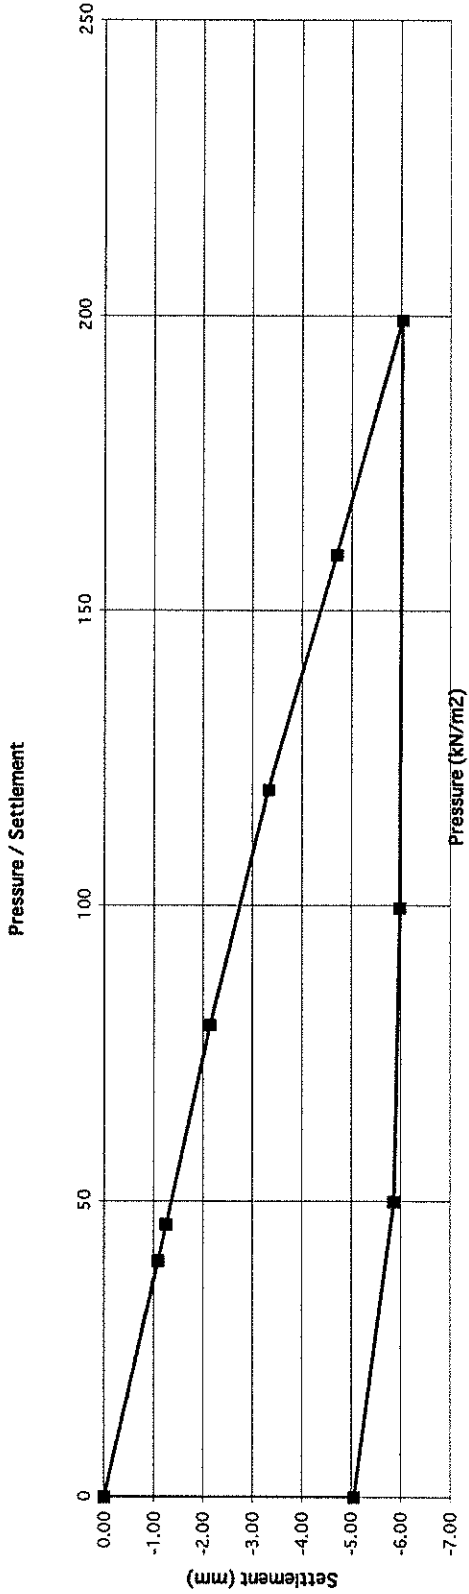
Test No. PBT03 - Reload	Location TP03R																				
Depth 0.6m bgl	Client DBFL	Easting (m)																			
Plate Diameter: 300 mm		Northing (m)																			
Test Method BS 1377: Part 9: 1990 Test4 - Incremental Loading Test		Ground Level (mOD)																			
Technician J.Reger		Sample Ref No. N/A																			
Authorised by		Depth 0.00	m bgl																		
Date 03/05/2023

<p>The graph plots Settlement (mm) on the y-axis (0.00 to -7.00) against Pressure (kN/m²) on the x-axis (0 to 250). The curve shows a non-linear relationship, starting at (0,0) and reaching approximately (200, -6.5). Key data points are marked with squares.</p>

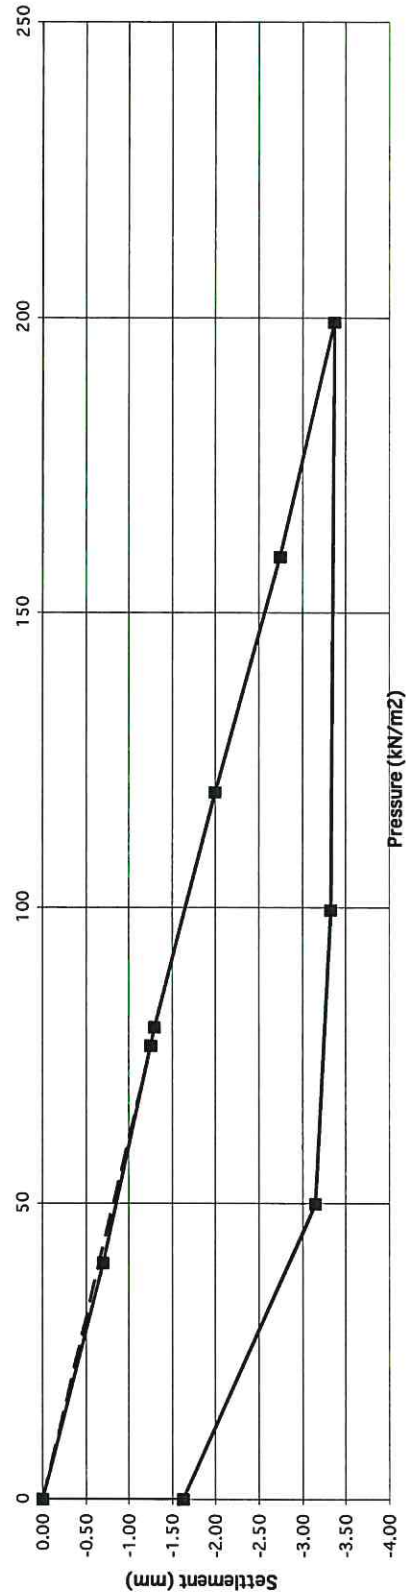
PLATE TEST REPORT SHEET (F3.1)		Applied Pressure/Settlement Curve	
Reference No. R144701 Contract Monaghan Active Travel Test No. PBT05 - load Location TP05R Depth 0.5m bgl Client DBFL Plate Diameter: 300 mm Test Method BS 1377: Part 9: 1990 Test4 - Incremental Loading Test Technician I. Reder Authorised by I. Reder Date 03/05/2023	Description of soil under test (natural soil, placed fill, sub-base) MADE GROUND (sandy gravelly clay, angular cobbles, bou Easting (m) Northing (m) Ground Level (mOD) Sample Ref No. N/A Depth 0.00 m bgl

Gradient at 1.25 mm settlement intersection = 61 Modulus of subgrade reaction = 28 MPa/m Correction factor applied = 0.46 as per HD 25-26/10		Equivalent CBR value in accordance with NRA HD25-26/10 3.1 %

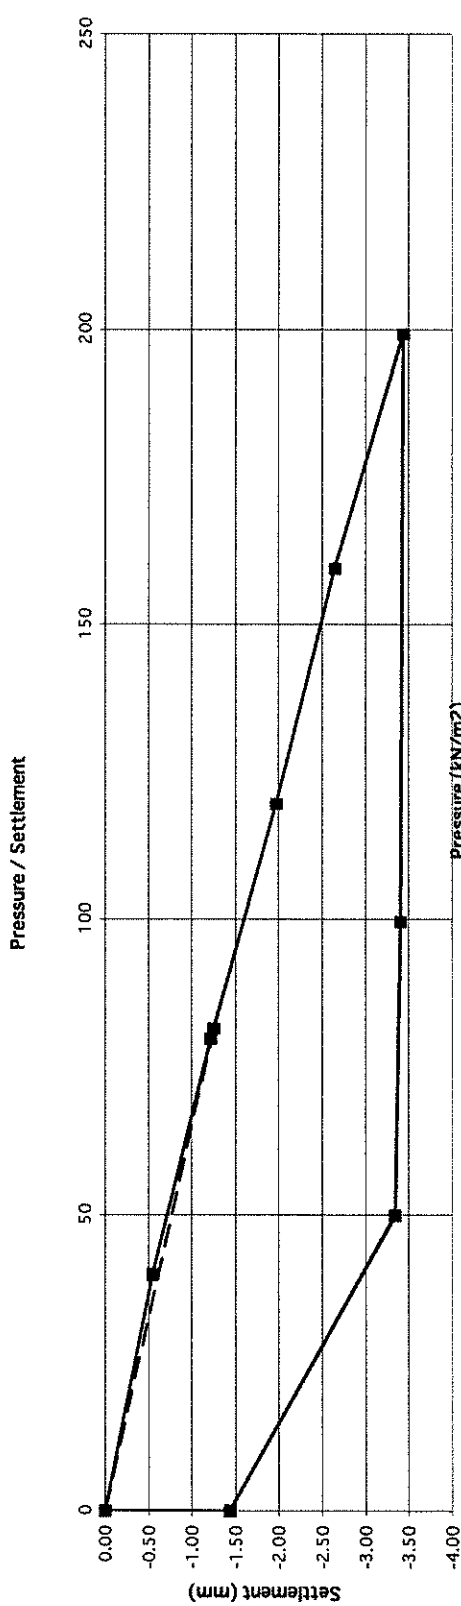
PLATE TEST REPORT SHEET (F3.1)		Applied Pressure/Settlement Curve	
Reference No. R144701 Contract Monaghan Active Travel Test No. PBT05 - Reload Location TPO5R Depth 0.5m bgl Client DBFL Plate Diameter: 300 mm Test Method BS 1377: Part 9: 1990 Test4 - Incremental Loading Test Technician I.Reder Authorised by [Signature] Date 03/05/2023	Description of soil under test (natural soil, placed fill, sub-base) MADE GROUND (sandy gravelly clay, angular cobbles, bou Easting (m) Northing (m) Ground Level (mOD) Sample Ref No. N/A Depth 0.00 m bgl

Gradient at 1.25 mm settlement intersection = 65 Modulus of subgrade reaction = 30 MPa/m Correction factor applied = 0.46 as per HD 25-26/10	
		Equivalent CBR value in accordance with NRA HD25-26/10 3.5 %

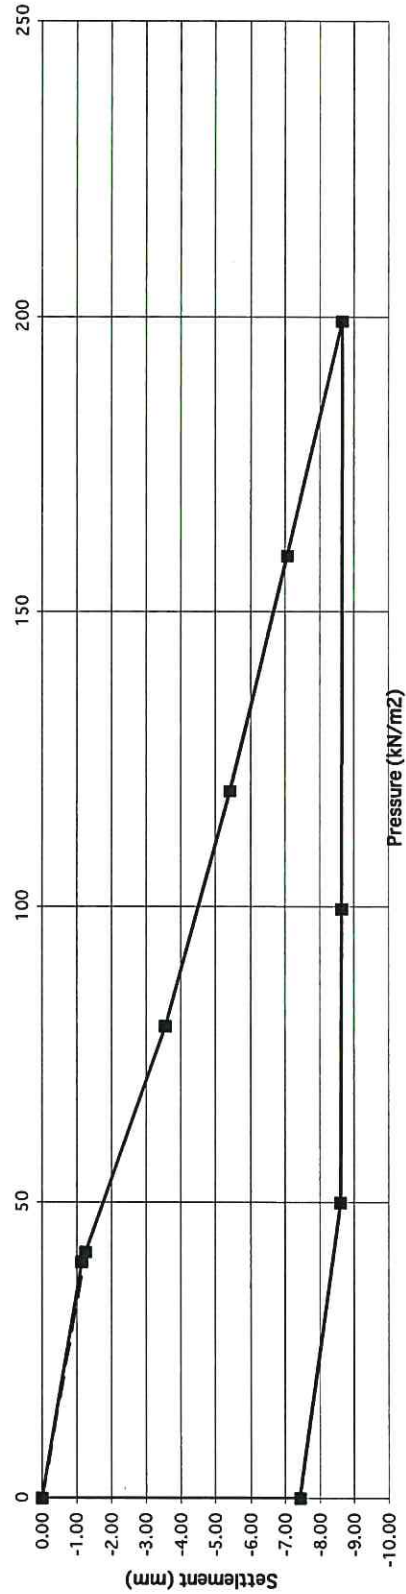
PLATE TEST REPORT SHEET (F3.1)		Applied Pressure/Settlement Curve																									
Reference No. R144702 Contract Monaghan Active Travel Test No. PBTO6 - load Location TP06R Depth 0.6m bgl Client DBFL Plate Diameter: 300 mm Test Method BS 1377: Part 9: 1990 Test4 - Incremental Loading Test Technician J. Reder Authorised by Date 03/05/2023	Description of soil under test (natural soil, placed fill, sub-base) Greyish brown, slightly sandy gravelly CLAY with cobbles Easting (m) Northing (m) Ground Level (mOD) Sample Ref No. N/A Depth 0.00 m bgl

<p>The graph plots Settlement (mm) on the y-axis (0.00 to -10.00) against Pressure (kN/m²) on the x-axis (0 to 250). The curve shows a non-linear relationship, starting at (0,0) and reaching approximately (200, -9.5). Key data points from the graph are as follows:</p>

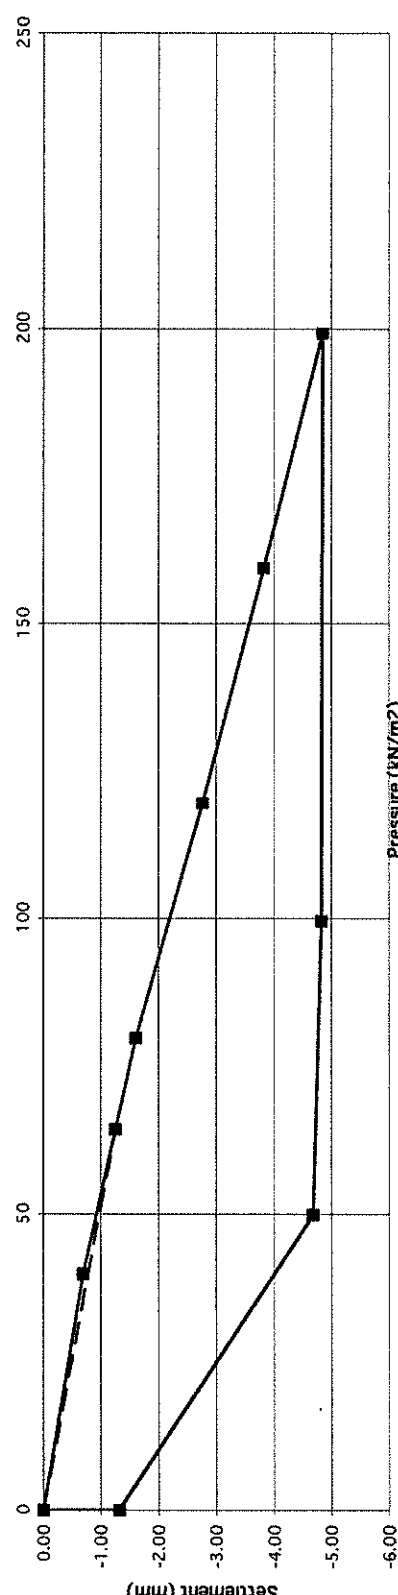
Test No. PB107 - load	Location TP07R		
Location	Depth 0.6m bgl	Easting (m)	
Client DBFL	Plate Diameter: 300 mm	Northing (m)	
Test Method BS 1377: Part 9: 1990 Test4 - Incremental Loading Test	Technician I.Reider	Ground Level (mOD)	
Authorised by	Date 03/05/2023	Sample Ref No. N/A	
		Depth 0.00 m bgl

Gradient at 1.25 mm settlement intersection = 51 Modulus of subgrade reaction = 24 MPa/m Correction factor applied = 0.46 as per HD 25-26/10		Equivalent CBR value in accordance with NRA HD25-26/10 2.3 %
